Part number(s): 900209-10, 900211-10, 900212-10, 900380-10, 900381-10, 900443-XX-XX, PSCB

Description: Low PIM cable support mount designed to secure Cable Support Blocks to structural members at a cell sit using PIM Shield Cable Straps. The Cable Support Blocks are installed onto a stainless-steel threaded rod kit, which is secured using a plastic Cable Support Base. The plastic straps and plastic Cable Support Base eliminate metal-to-metal contact between the threaded rod and the site structural member. Assembly torque = 10 FT-LB on all fasteners.

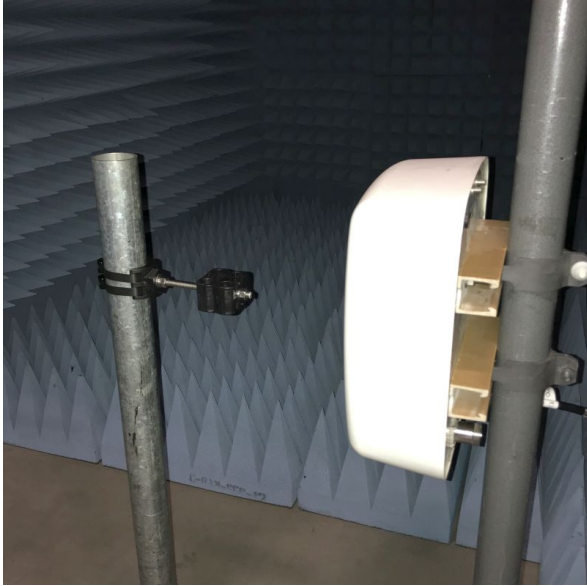
FRONT

Test set-up photos 1900 MHz:
