Radiated PIM Test Report

Part number(s): 900731-xx, 009718-xx-10, 900711-10, PSCB

Description: Low PIM cable support mount designed to secure multiple Cable Support Blocks to galvanized steel pipe in high risk PIM zones. Mount is formed by the combination of two kits: 009718-xx-10 Cable Support Bracket and 900731-xx Rail Kit. The rail kit includes an extruded aluminum rail with custom channel runners designed to prevent metal-to-metal contact. The Cable Support Brackets utilize heavy duty galvanized steel saddle brackets clamped to the pipe using 2x 0.375-inch threaded rods. Assembly torque = 10 FT-LB on all fasteners.

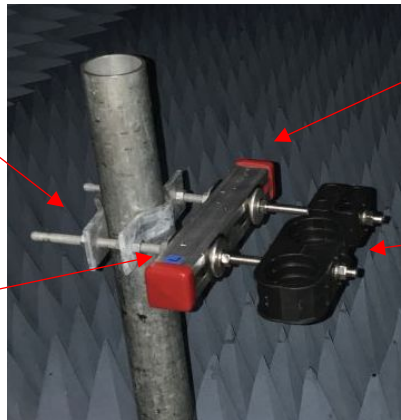
Cable Support Bracket

- 009718-01-10
- 009718-02-10

Rail Kit

- 900731-12
- 900731-24

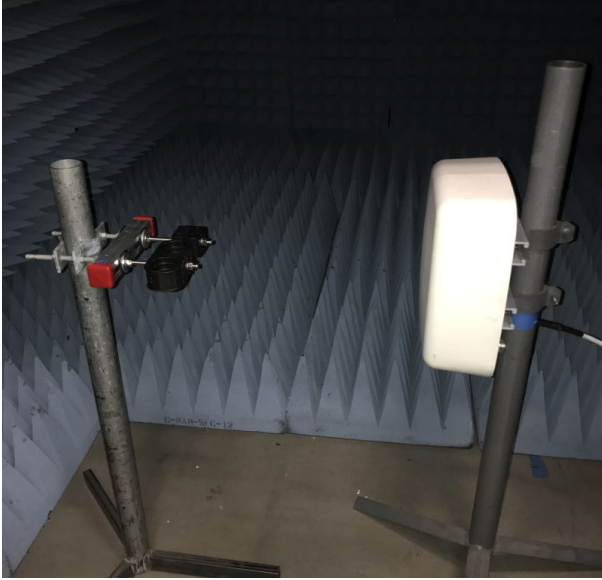
FRONT

Test set-up photos 700 MHz:

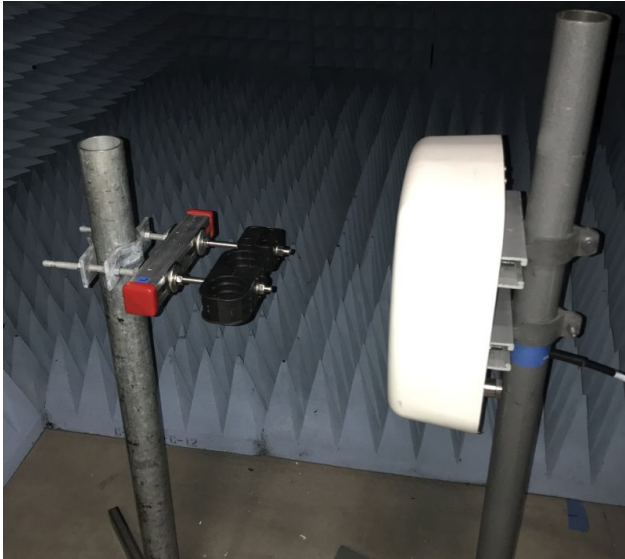
FRONT

Test set-up photos 1900 MHz:
