## PIM Hygiene

Most PIM sources found near base station antennas are caused by either loose metal-to-metal contact or by highly non-linear corrosion products. While many of these sources are obvious, some are not so obvious. This application note documents the common sources of PIM found in high-risk PIM zones near antennas and suggests corrective action to take when performing PIM Hygiene.

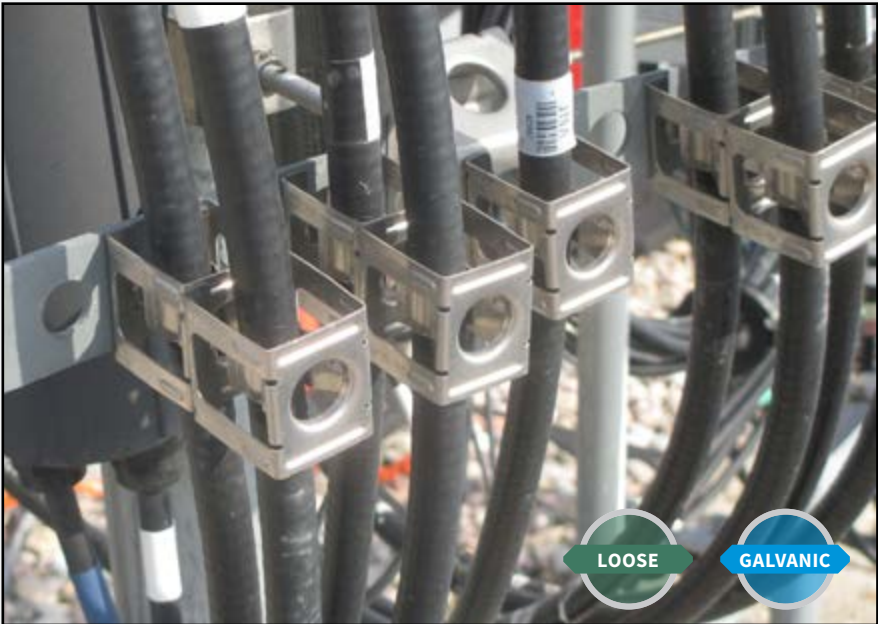
PIM Source	Resolution
<p style="text-align: center;"><b>STAINLESS-STEEL SNAP-IN CABLE HANGERS</b></p>

<ul style="list-style-type: none"> <li>Replace metal snap-in cable hangers with low PIM design using “all plastic” or “hybrid” plastic/metal construction</li> </ul> <p style="text-align: center;"><b><u>PSPS-XXXX-10</u></b></p>

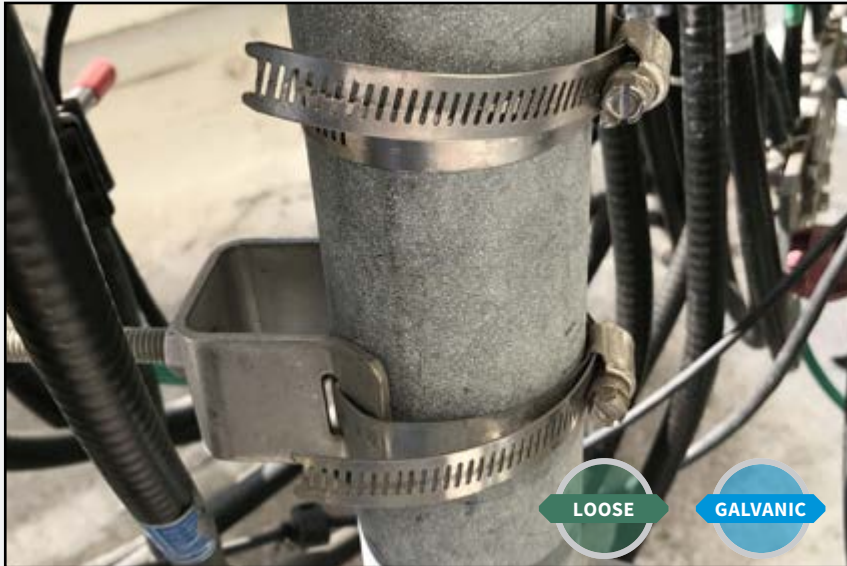
STAINLESS-STEEL HOSE CLAMPS

- Replace hose clamp with acetal plastic strap(s)

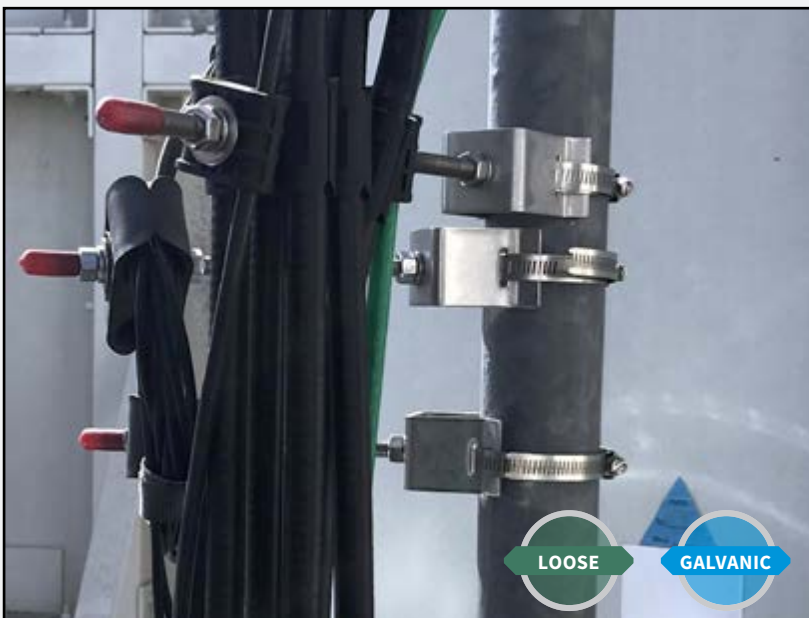
STAINLESS-STEEL STAND-OFF ADAPTERS / SUPPORT BRACKETS

- Replace stand-offs and support brackets with plastic alternatives

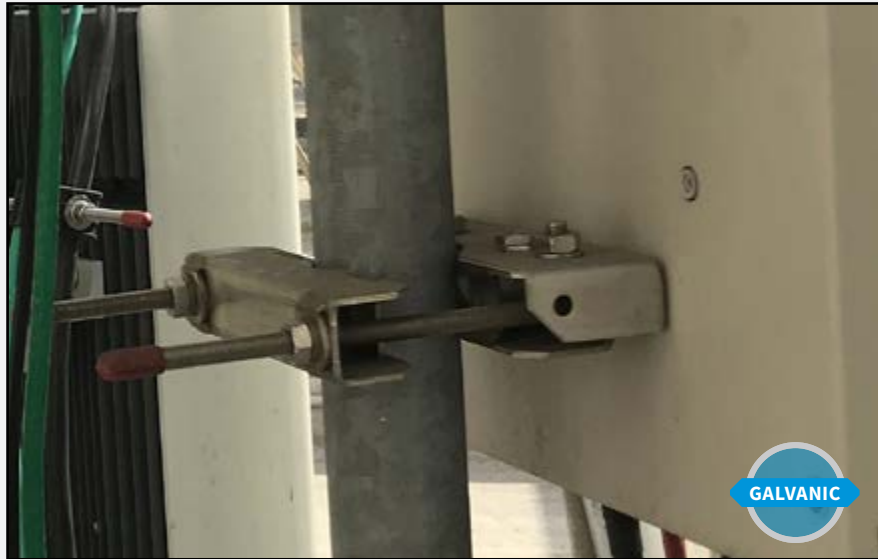
STAINLESS-STEEL RADIO AND ANTENNA MOUNTING BRACKETS

- If available, replace the stainless-steel brackets with new design provided by the OEM
- If new brackets are not available, loosen hardware and apply No-Ox to surfaces where stainless steel touches galvanized steel.
- Re-torque hardware per manufacturer's specifications when finished

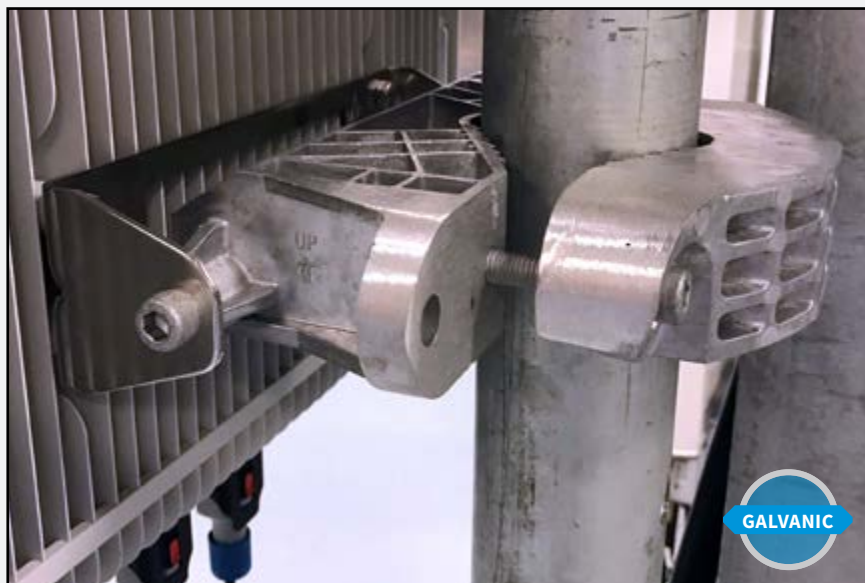
ALUMINUM RADIO AND ANTENNA MOUNTING BRACKETS

- Do nothing
- Aluminum is closely matched to galvanized steel on the galvanic series. As a result, PIM producing corrosion products are unlikely
- Only take corrective action (disassemble and apply No-Ox to surfaces) if PIM Hunting determines this connection is a problem

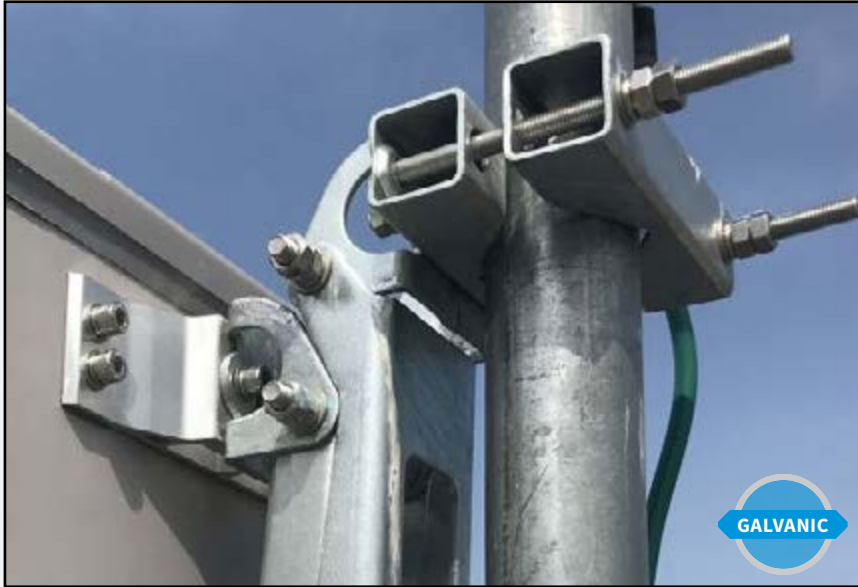
**STAINLESS-STEEL THREADED FASTENERS WITH ALUMINUM OR GALVANIZED STEEL BRACKETS (RADIOS, ANTENNAS, FILTERS, ETC)**

- If available, replace the stainless-steel hardware with galvanized steel hardware approved by the OEM
- If new hardware is not available, do nothing
- Only take corrective action (disassemble and apply No-Ox to surfaces) if PIM Hunting determines this connection is a problem

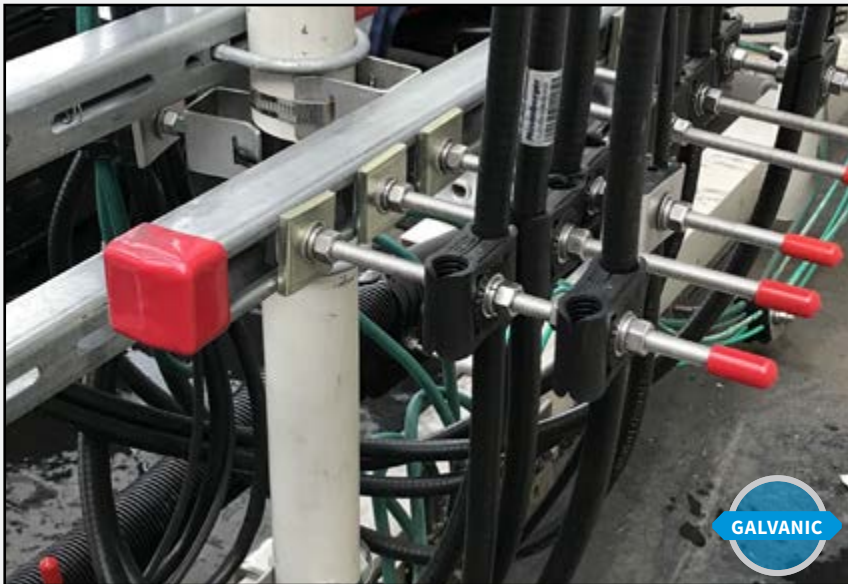
**MIXED STAINLESS-STEEL AND GALVANIZED STEEL (CABLE SUPPORT HARDWARE)**

- Replace threaded hardware with correct material / finish to eliminate galvanic mismatch
- Replace support system with low PIM design if unable to eliminate all galvanic mismatches

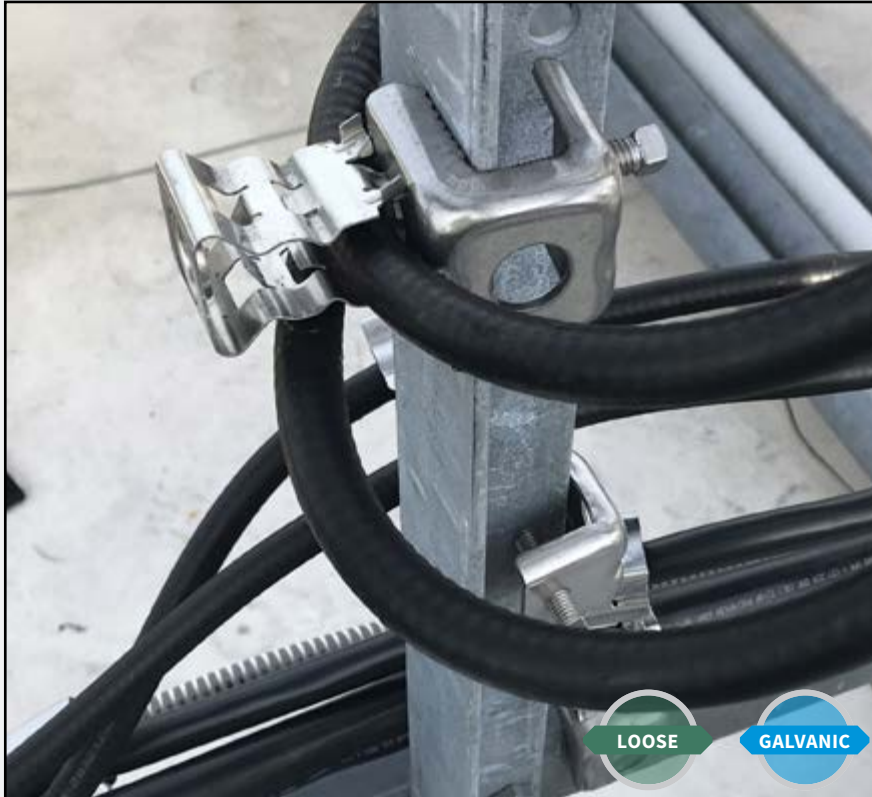
STAINLESS-STEEL ANGLE ADAPTERS

- Replace steel angle adapters with plastic angle adapters
- Replace stainless-steel angle adapters with galvanized steel angle adapters
  - Set screw must also be galvanized steel
  - Apply No-Ox to end of set screw at point of contact with the angle
  - Be careful to install with gap between inside of adapter and top of angle flange

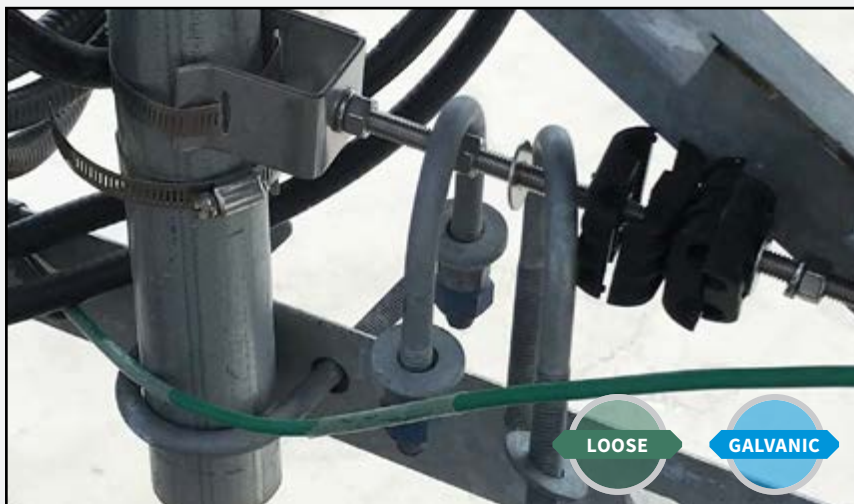
UNUSED MOUNTING HARDWARE

- Remove any unused cable support hardware left on the support frame

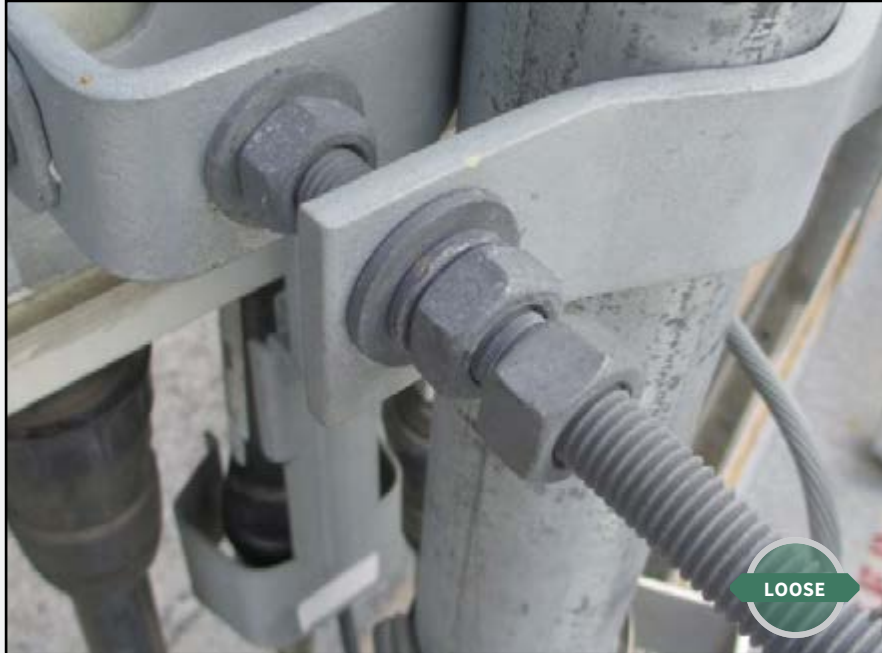
LOOSE NUTS & BOLTS

- Tighten all nuts and bolts on antenna mounting frame to OEM's specifications
- Tighten all nuts and bolts on radio and antenna mounting brackets to OEM's specifications
- For nuts and bolts securing plastic cable support blocks, visually verify that all split washers are compressed

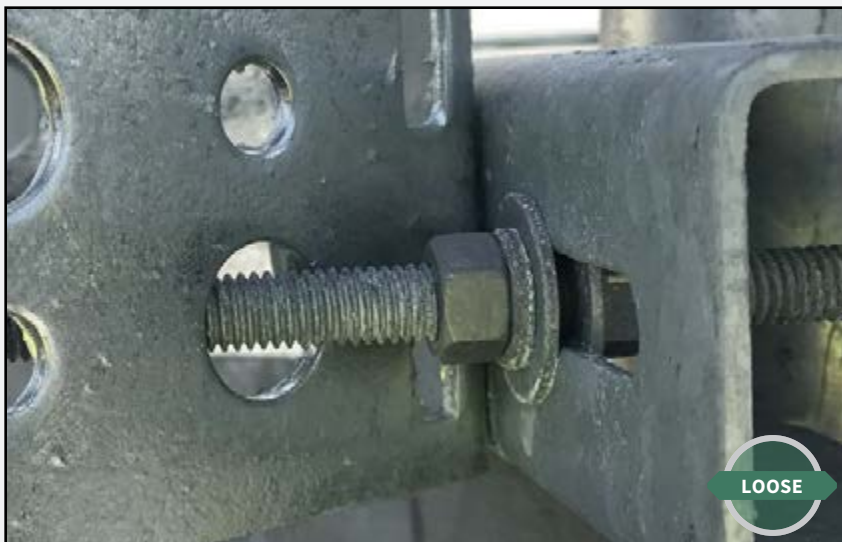
METAL HARDWARE TOUCHING OTHER METAL HARDWARE

- Re-position hardware to eliminate contact

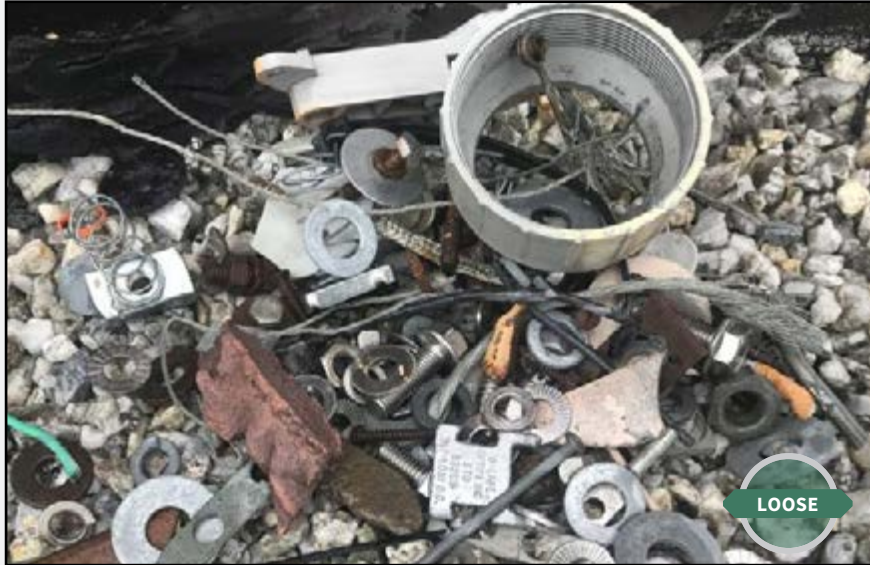
METAL TRASH / SCRAP LEFT ON SITE

- Remove all metal trash (steel, aluminum, copper, etc.)

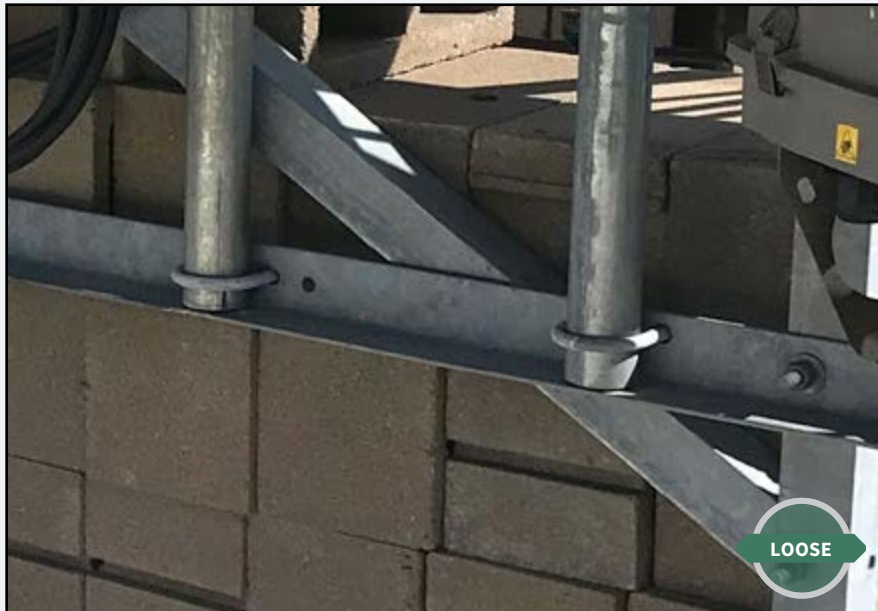
SUPPORT FRAME MEMBERS TOUCHING EACH OTHER (LOCATIONS OTHER THAN BOLTED CONNECTIONS)

- Loosen and re-position frame members to eliminate contact
- Re-torque nuts and bolts on frame to OEM's specifications

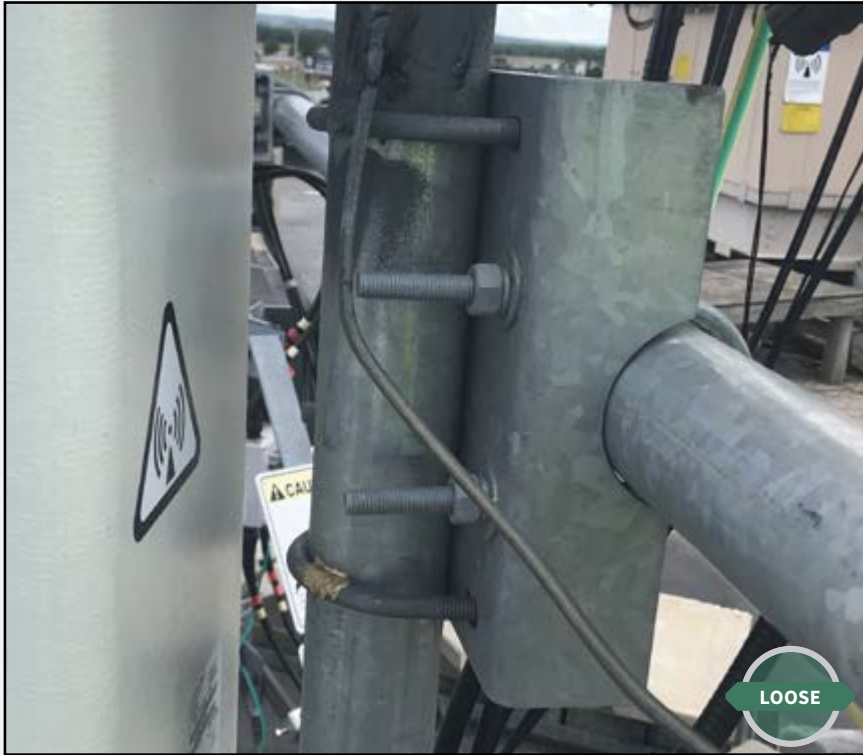
SUPPORT FRAME INTERCONNECTS

- Other than making sure the connections are tight, it is best to do nothing during hygiene
- Only take corrective action (disassemble, clean and apply No-Ox to surfaces) if PIM Hunting determines this connection is a problem
- LAST RESORT – install PIM tape to prevent RF energy from reaching the inconsistent points of contact

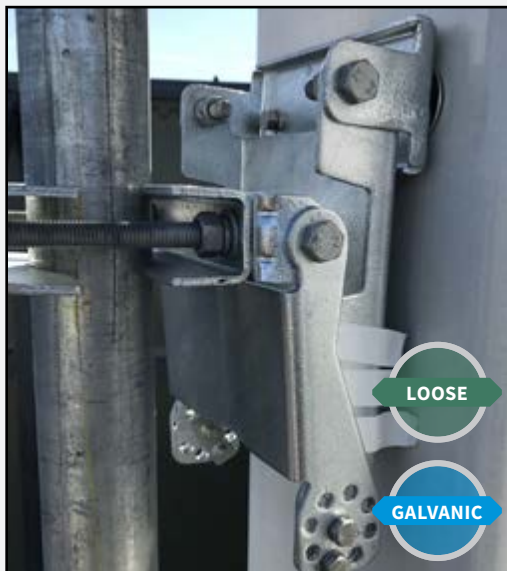
ANTENNA MECHANICAL DOWNTILT BRACKETS

- Eliminate mechanical tilt bracket (if sufficient electrical tilt is available)
- Replace mechanical tilt bracket with new low PIM design available from the antenna manufacturer
- Loosen bracket, adjust and re-tighten to eliminate surfaces touching at 0° tilt
- Install vinyl tape between surfaces where metal is over-lapping metal
- LAST RESORT – install PIM tape to prevent RF energy from reaching the inconsistent points of contact

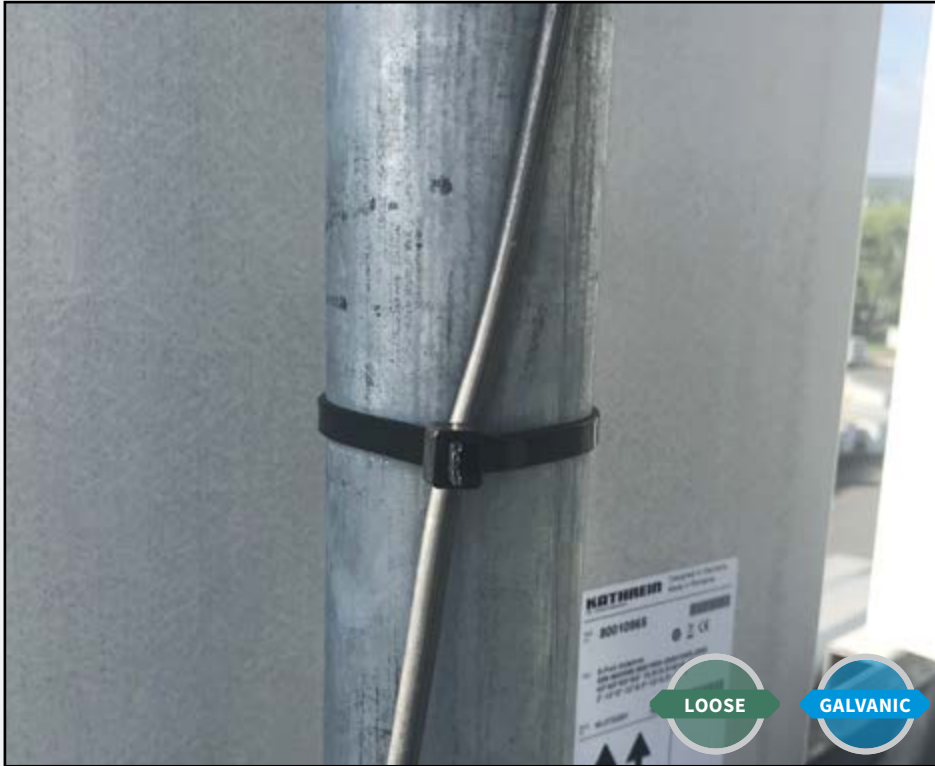
UNSHIELDED GROUNDING WIRES TOUCHING METAL SURFACES

- Re-route wire as required and provide secure insulation at all points where unshielded wire is able to touch other metal surfaces
- Acceptable insulation methods may include:
  - Rubber grommets
  - Cable support blocks
  - Plastic snap-ins
- Installing PIM tape over thermal weld area will prevent direct radiation of an imperfect weld. The wire, however, may act like an antenna and channel energy to the weld. Since this is not a common issue, better to take correction action at the weld only when PIM Hunting determines this is a problem

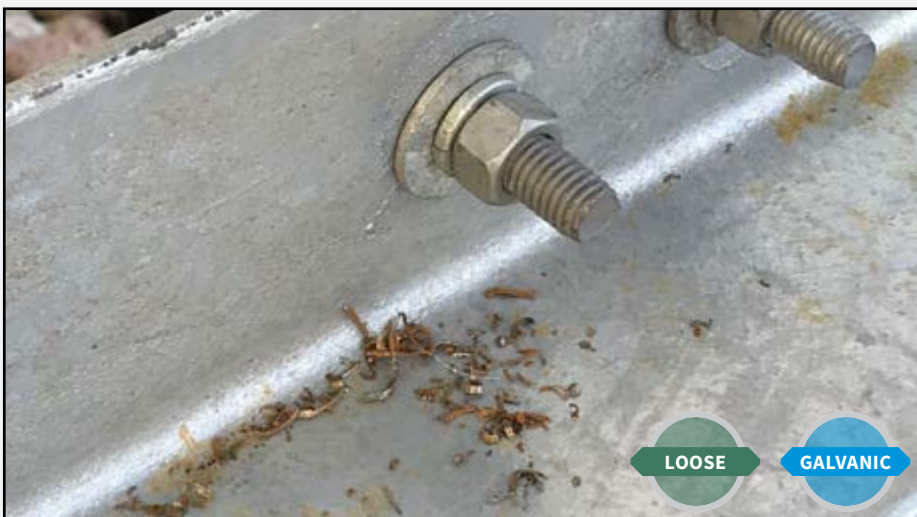
METAL SHAVINGS

- Remove all metal shavings (handheld shop vacuums are useful to make sure no shavings are left behind inside and outside of structural members)
- If aggregate is used to ballast roofing material below antennas, move rocks aside below antennas to make sure no shavings are present

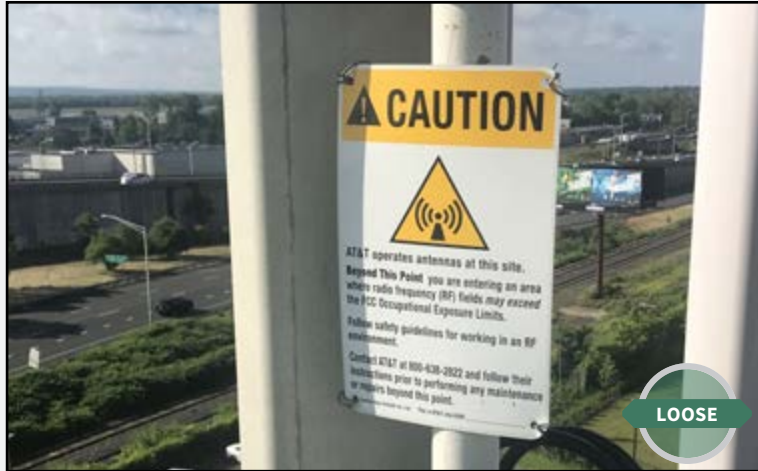
RF SAFETY SIGNS INSTALLED NEAR ANTENNAS

- Replace metal sign attachment with plastic, low PIM RF safety sign support

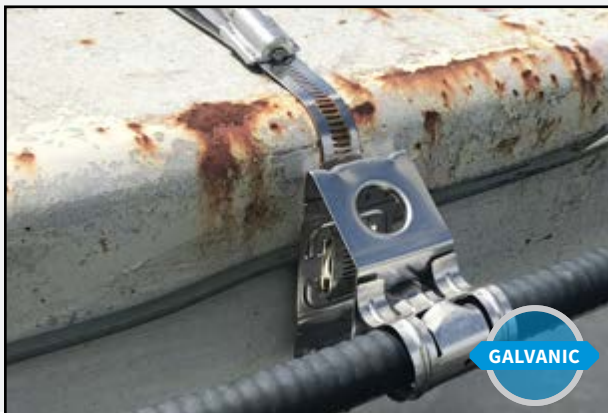
RUSTY SURFACES

- Remove rust using wire brush or sandpaper
- Wipe surface with clean rag with solvent to remove metal dust
- Apply zinc rich paint (Cold Galv.)

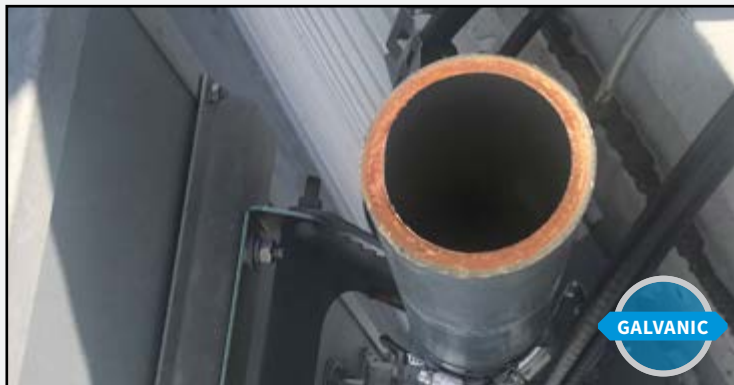
BURS ON ENDS OF PIPES, ANGLE MEMBERS AND STEEL STRUT

- Remove burrs at ends of steel members using a file.
- Wipe surface with clean rag with solvent to remove metal dust
- Apply zinc rich paint (Cold Galv.)

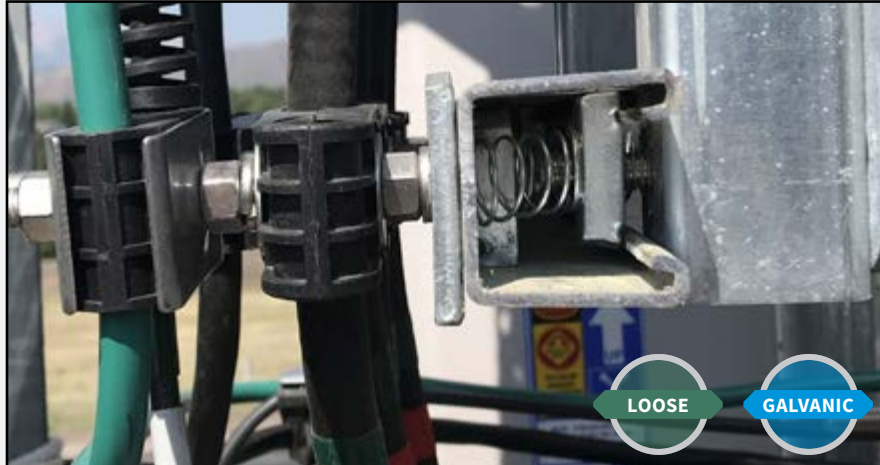
STEEL STRUT - SPRING NUTS

- The spring is typically press-fit into the nut and can be removed using pliers
- If stainless-steel spring nuts are installed inside galvanized or zinc plated strut, replace the spring nuts with a galvanized steel nuts (with spring removed)

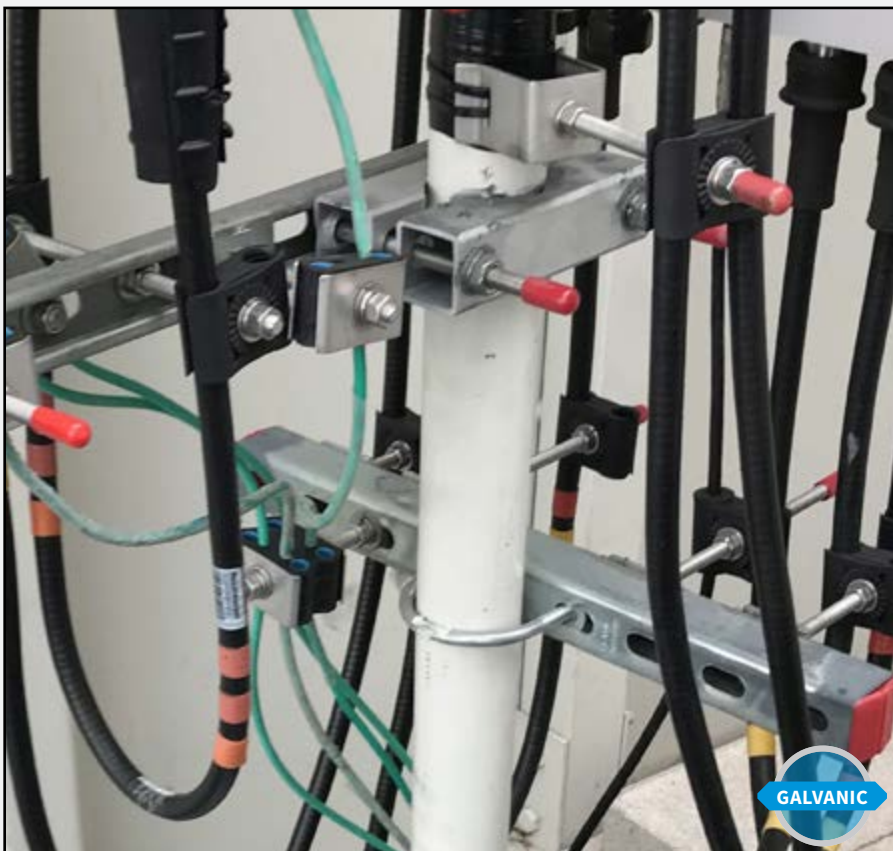
STEEL STRUT - ANTENNA MOUNTING PIPE CONNECTIONS

- If steel strut is used for cable support, replace strut with low PIM alternative
- If steel strut is used for structural support of radios or other heavy equipment, do not replace with low PIM alternative without operator's approval
- If existing mount is not replaced, disassemble and apply No-ox to all dissimilar metal surfaces. Re-torque hardware to insure tight connections

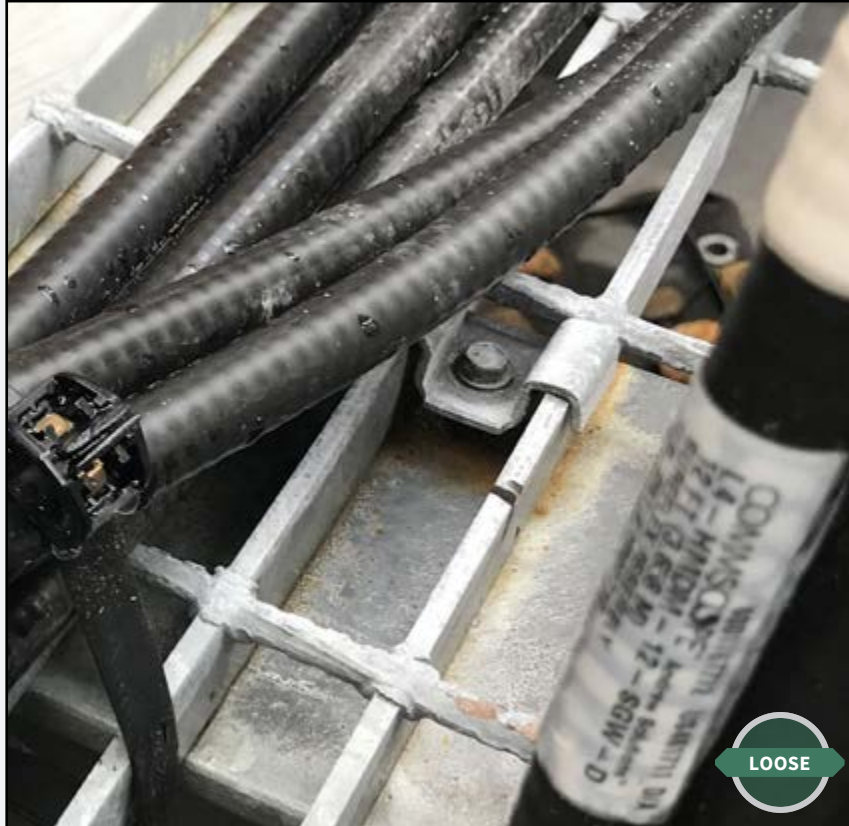
METAL GRATES NEAR ANTENNAS

- The best answer is to replace metal grates with FRP grates, but this is not something that can take place during hygiene
- Best you can do during hygiene is make sure all clips securing the grate are tight
- PIM Blankets can be placed over the grate while PIM Hunting to verify if the grate is causing PIM interference

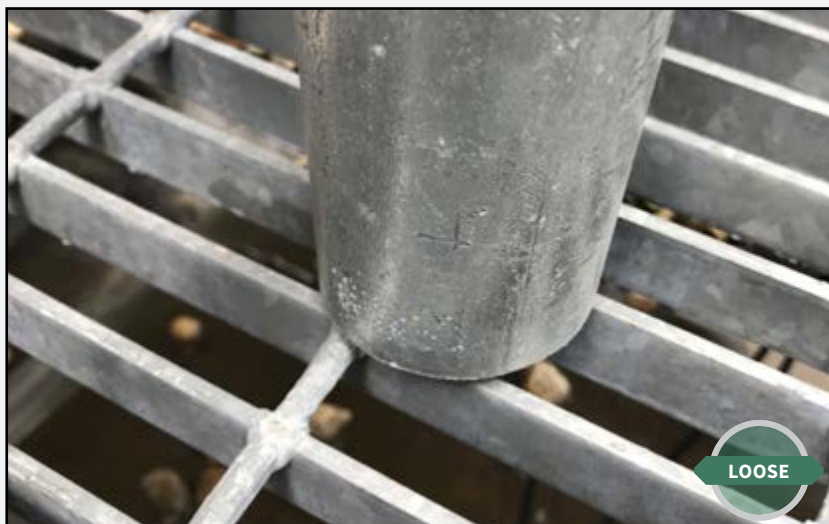
ANTENNA MOUNTING PIPE TOUCHING METAL GRATE

- Loosen and re-position antenna mounting pipe to eliminate contact
- Re-torque nuts and bolts on pipe support to OEM's specifications

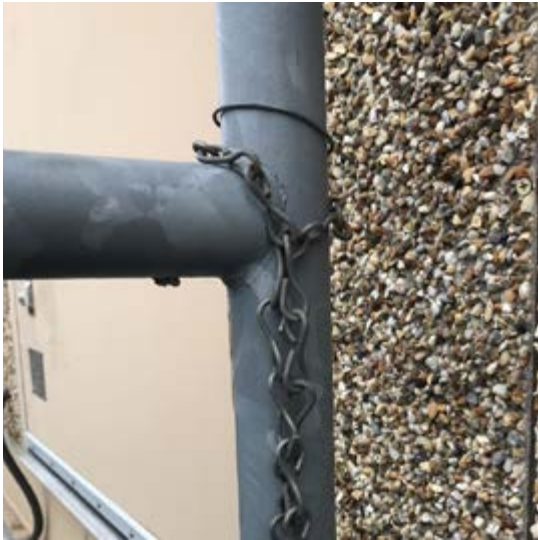
**CHAIN ON ANTENNA MOUNTING PIPE USED TO HOLD NEARBY RADIO CABINET DOOR OPEN**

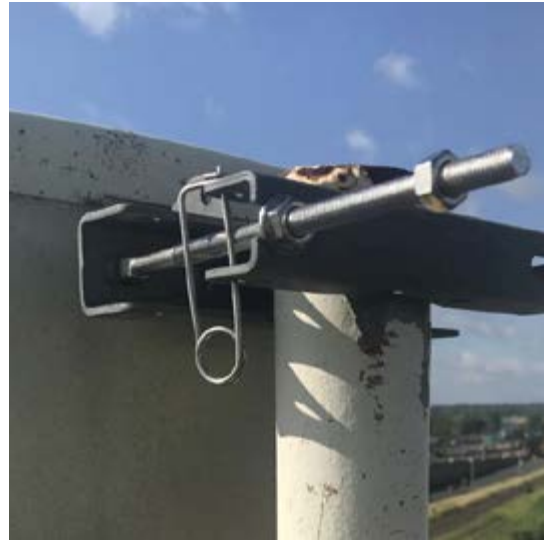
**SPRING CLIP ON ANTENNA MOUNTING BRACKET**

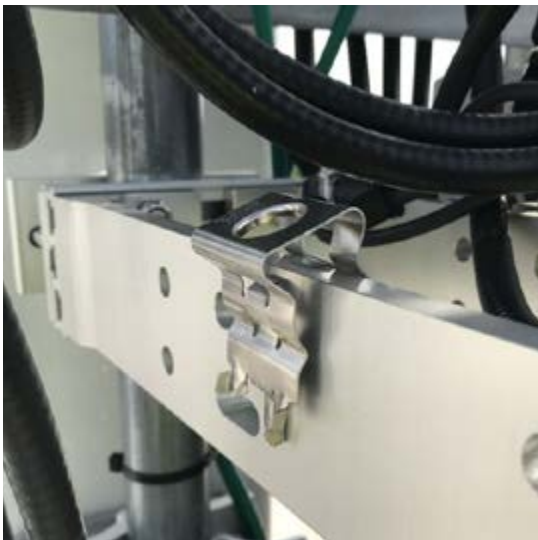
**RANDOM SITE HARDWARE LEFT IN UNEXPECTED PLACES**

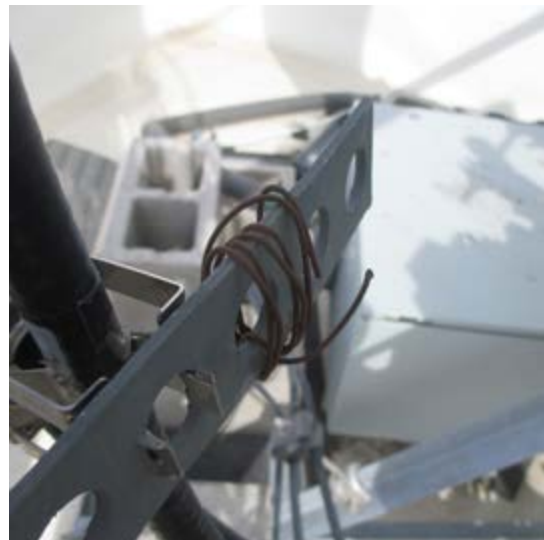
**RUSTY COIL OF WIRE ON CABLE SUPPORT BAR**

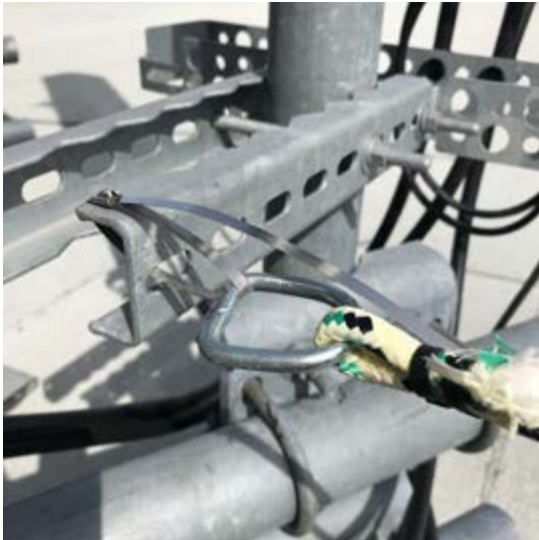
STEEL BANDING SECURING RF SAFETY ROPE

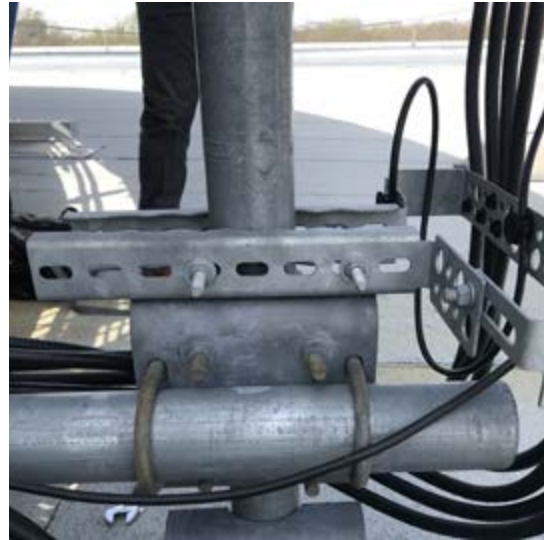
LOW PIM BRACKET CONTACTING SUPPORT BRACKET

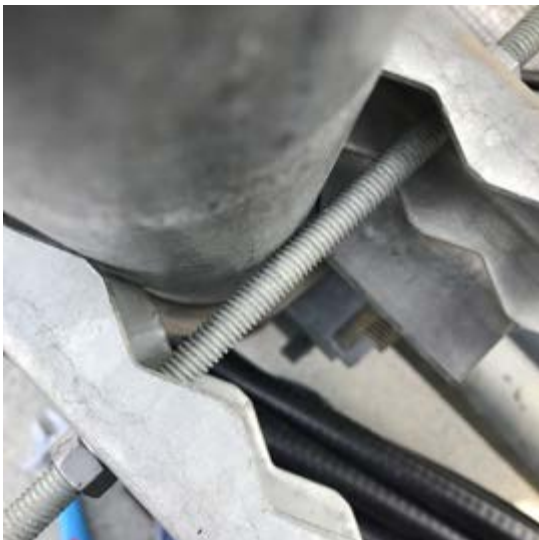
LOW PIM BRACKET INSTALLED WITH THREADED ROD TOUCHING THE PIPE

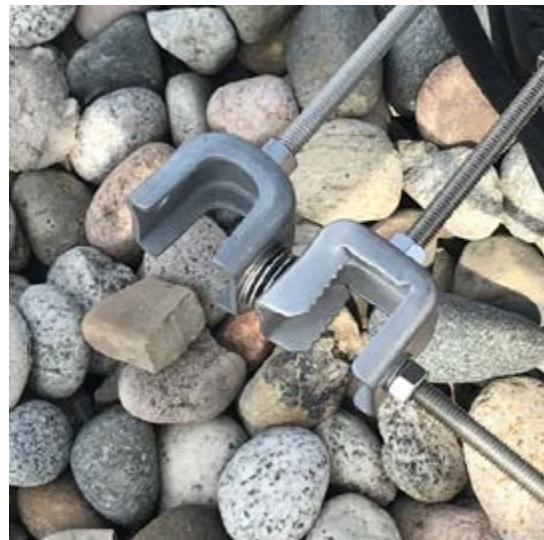
STACK OF LOOSE WASHERS INSTALLED ON SUPPORT

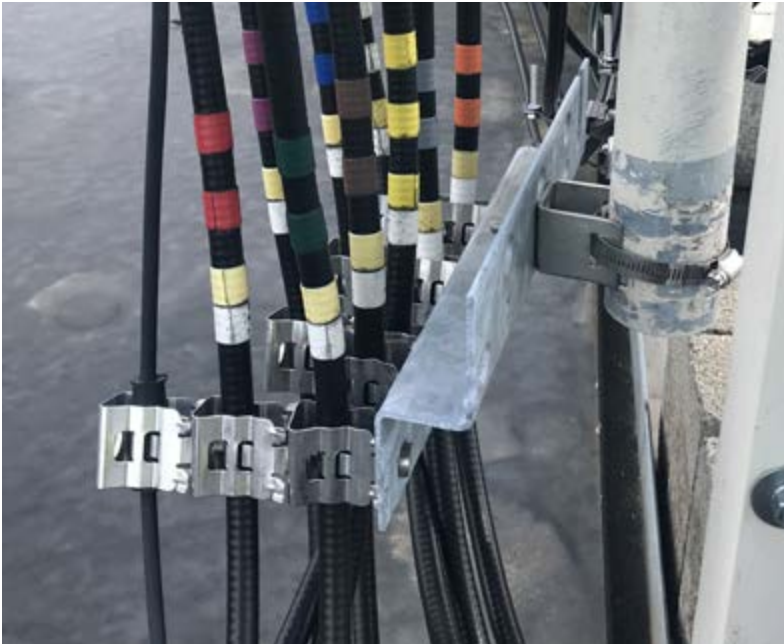
**ANSWER: 6**

- Stainless-steel hose clamp on galvanized steel pipe (galvanic)
- Stainless-steel stand-off installed on galvanized steel pipe (galvanic)
- Stainless-steel stand-off securing galvanized steel Z-bracket (galvanic)
- Stainless-steel hardware securing galvanized steel Z-bracket (galvanic)
- Metal snap-ins (loose)
- Metal snap-ins installed in galvanized steel bracket (galvanic)

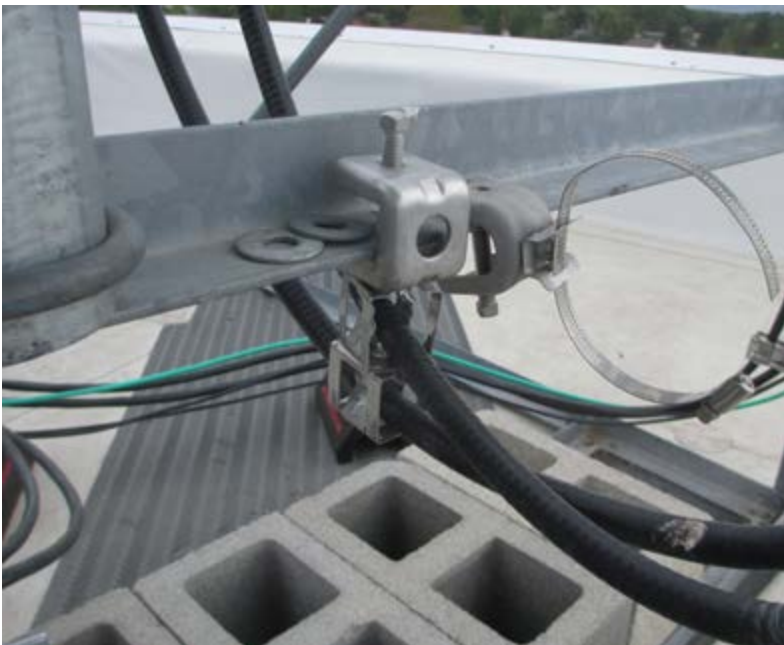
**ANSWER: 8**

- Stainless-steel angle adapter installed on galvanized steel angle (galvanic)
- Stainless-steel set screws digging into galvanized steel angle (galvanic)
- “Neck” of angle adapter touching top of angle flange (loose)
- Washers left behind touching angle (loose)
- Un-used hose clamp (loose)
- Stainless-steel clip installed on galvanized steel angle adapter (galvanic)
- Pipe resting on support frame
- Metal snap-ins
