## Low PIM Alternatives for Metal Angle Adapters

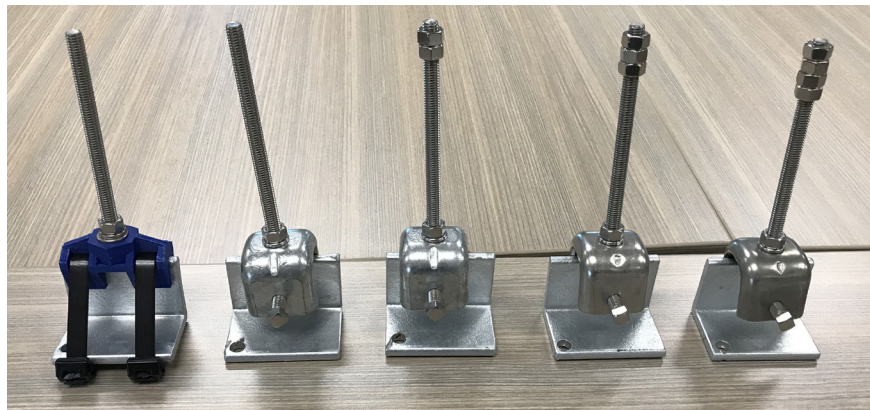
The loose metal-to-metal contact issues identified would likely be found and mitigated during site certification PIM tests. The galvanic corrosion issues, however, take time to develop and are likely the root cause of the time-related problems identified in the field. To test this theory, five angle adapter configurations were assembled and put through salt fog testing to simulate accelerated weathering. “Off-the-shelf” galvanized steel and stainless steel angle adapters were used for the test. Half were attached per the manufacturer’s instructions and the other half were installed with NoOx conductive grease applied at the metal-to-metal interfaces. The thought here was that NoOx might protect the mating surfaces and prevent the formation of corrosion products. A fifth angle adapter concept was included in the tests that replaced the metal design with an all plastic design to prevent the possibility of galvanic corrosion.

**Plastic Concept   Galvanized Steel   Galvanized Steel with NoOx   Stainless Steel Concept   Stainless Steel with NoOx**

All five samples were assembled and subjected to radiated PIM tests prior to salt fog testing. The radiated PIM tests were dynamic, near field tests conducted in accordance with preliminary specification IEC 62037-8. Measurements were made at both 700 MHz and 1900 MHz. After salt fog testing, the samples were washed with warm water to remove the salt residue, allowed to dry and re-tested using the radiated PIM process.

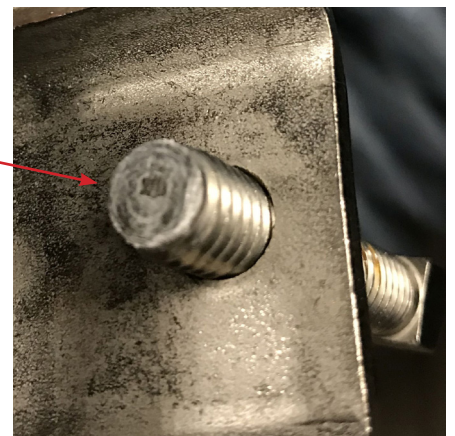
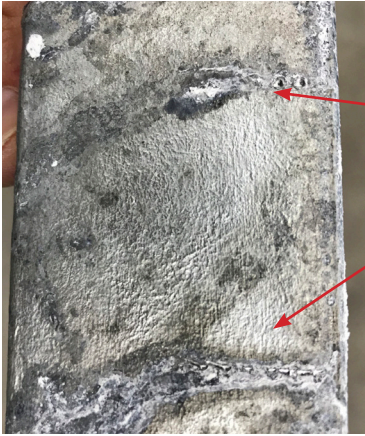
**Corrosion Products Seen Where Teeth of Stainless-Steel Adapter Contacted Galvanized Steel Angle**

Post salt-fog, all samples passed the radiated PIM test except for the all stainless-steel adapter without NoOx. The failing sample was disassembled and there was clear presence of corrosion products occurring between the set screw, the angle adapter bracket and the galvanized steel angle.

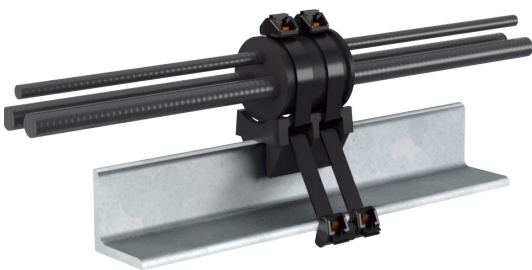
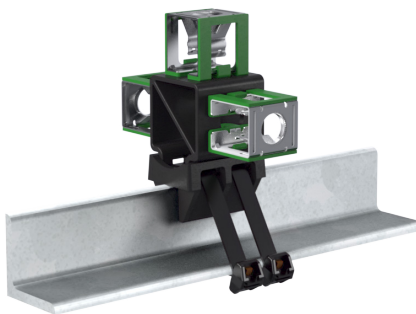
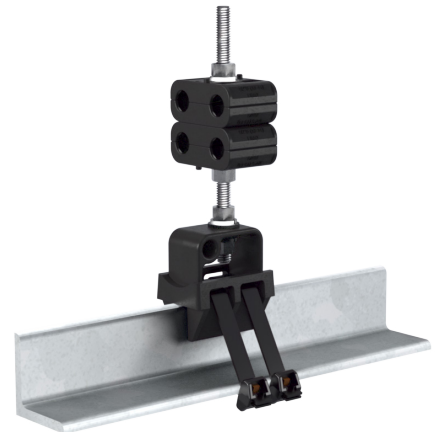
ConcealFab has developed an all-plastic “Universal” family of cable support products to mitigate sources of passive intermodulation at cell sites. The system includes a universal base that securely interfaces with the metal angle. Bundles of cables can be strapped directly to the base or an adapter can be installed with the base to launch threaded rods or to secure snap-in style hangers. Each component within the system is a molded, UV stable, glass-filled Nylon part designed to eliminate metal-to-metal contact and prevent galvanic mismatches.
