# EXTERNAL PIM REMEDICATION

Using PIM Shield™ Roofing Technology

## Executive Summary

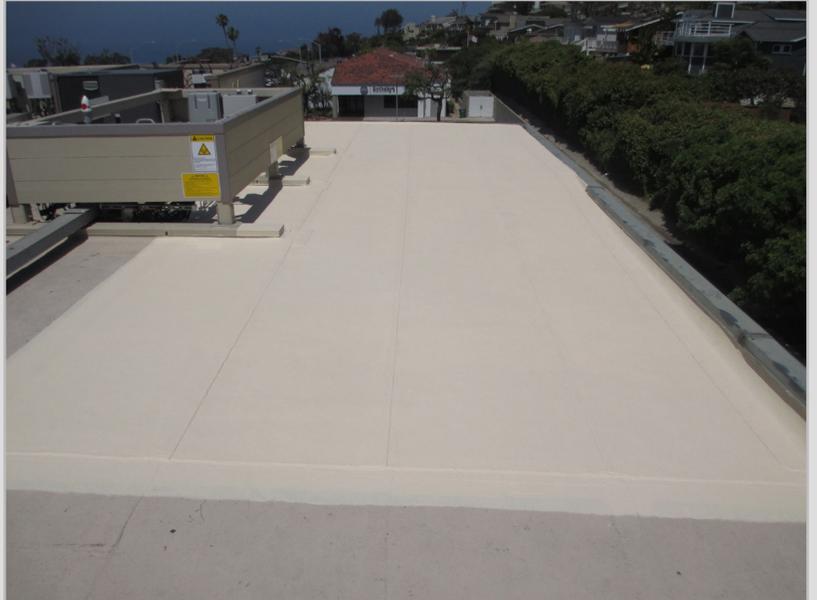
*PIM Shield Roofing System Installed*

The PIM mitigating material installed at this site was DynaLastic™ 180 FR PIM. This is a multiply Styrene-Butadiene-Styrene (SBS) modified bitumen roof membrane manufactured by Johns Manville and sold through ConcealFab. The material includes ceramic coated roofing granules bonded to the top surface with a special PIM mitigating layer sandwiched in the middle between two SBS modified bitumen layers. The material can be installed using industry standard hot asphalt or cold adhesive processes.

For this installation, Johns Manville MBR bonding and flashing adhesives were used to attach the membrane to the existing roofing surface. Johns Manville TopGard 4000 acrylic elastomeric coating was applied after installation for added protection and to meet aesthetic requirements. The material system complies with the applicable ASTM standards and carries both UL and FM approvals.

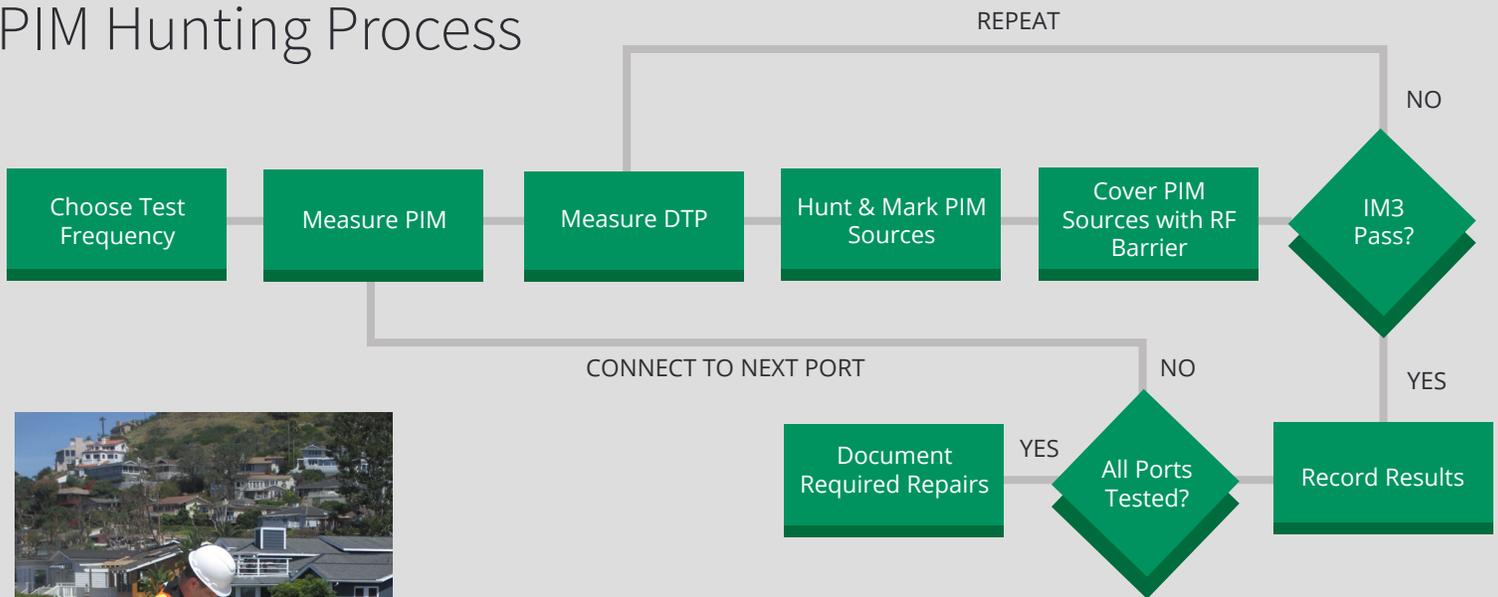
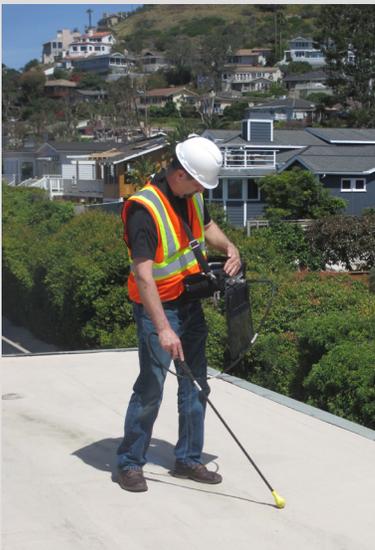
## PIM Hunting Process

Vertical Limit Construction ([www.verticallimit.com](http://www.verticallimit.com)) performed the RF measurements on this site following the external PIM investigation process outlined in the chart below. A Kaelus iQA-700H with RTF module was used to measure PIM, an Anritsu MS2720T with PIM Hunter probe was used to identify PIM source locations and ten ConcealFab PIM blankets, part number 007640-120060, were used to cover the PIM sources once identified.

A significant percentage of the area in front of and directly below the sector antennas was found to be generating PIM. Covering those areas with PIM blankets reduced the sector PIM to better than -90 dBm on all ports. PIM Blankets are useful as an aide during the test & measurement process but are not suitable as a long-term mitigation solution.

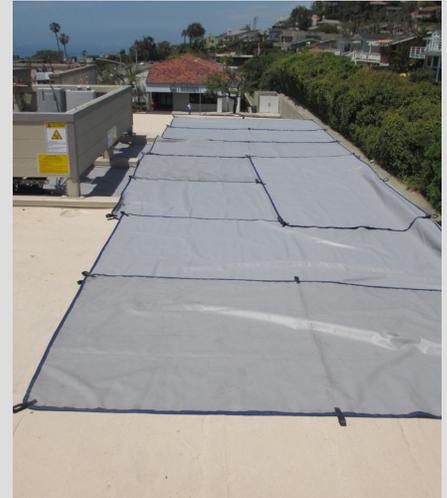
*PIM Blankets Deployed*

Port Identification	Starting PIM	PIM with Blankets Deployed	Improvement
1 Violet	-54.1 dBm	-90.1 dBm	36.0 dB
2 Violet	-55.9 dBm	-95.5 dBm	39.6 dB
3 Violet	-52.0 dBm	-97.2 dBm	45.2 dB
4 Violet	-62.2 dBm	-91.7 dBm	29.5 dB

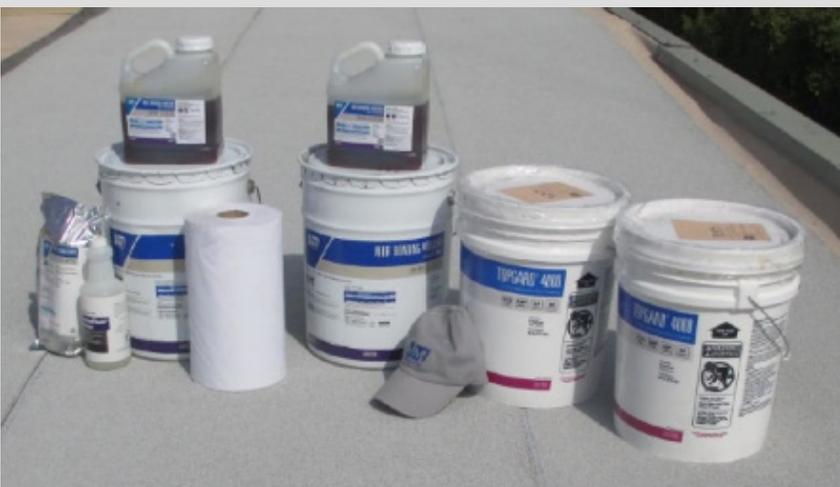
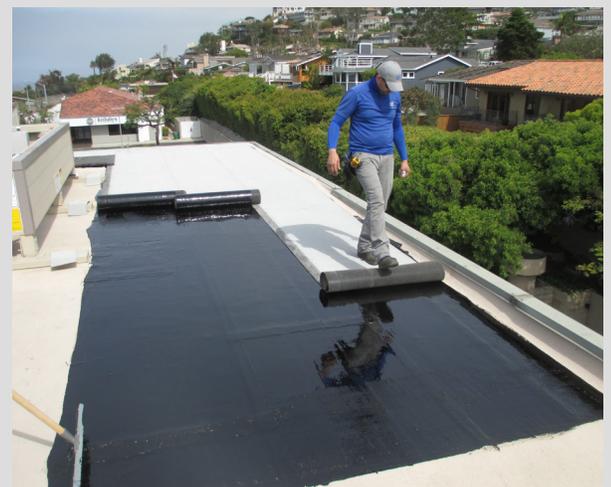
PIM Shield™ roofing material was deployed over the impacted area then permanently installed using MBR bonding and flashing adhesives per Johns Manville standard installation procedures. After installation, PIM was measured again to validate performance. A small area directly below one antenna required additional coverage to achieve the desired PIM performance. This area had been covered during the PIM blanket deployment but had accidentally not been covered with roofing material.

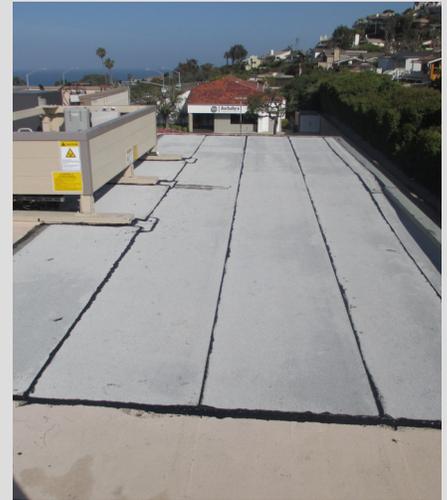
*PIM Shield Roofing Installed*

Port identification	Starting PIM	PIM Shield™ Installed	Improvement
1 Violet	-54.1 dBm	-94.8 dBm	40.7 dB
2 Violet	-55.9 dBm	-99.3 dBm	43.4 dB
3 Violet	-52.0 dBm	-106.2 dBm	54.2 dB
4 Violet	-62.2 dBm	-101.2 dBm	36.2 dB

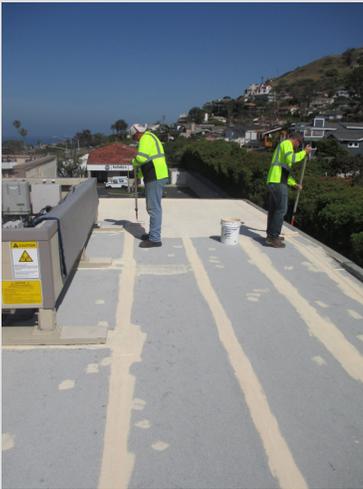
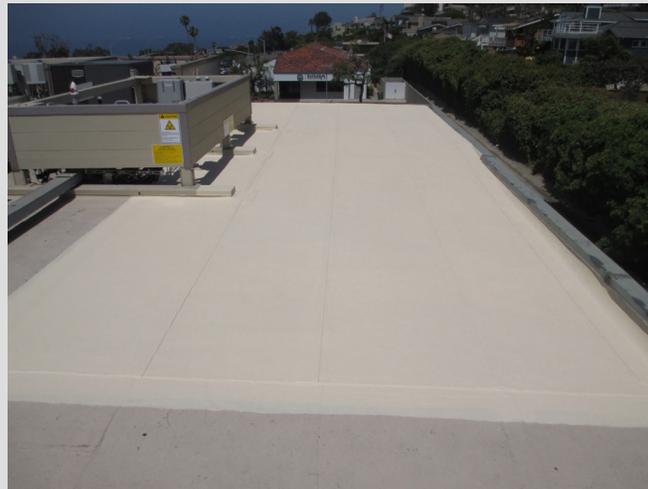
*Completed System with TopGard coating applied*

For added protection and to meet local aesthetic requirements, a layer of TopGard 4000 acrylic elastomeric coating was applied over the PIM Shield™ roofing material.

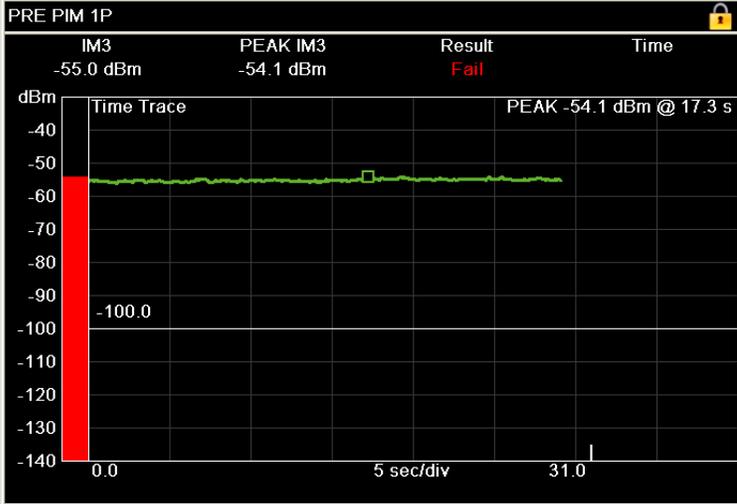
Starting PIM: -54.1 dBm

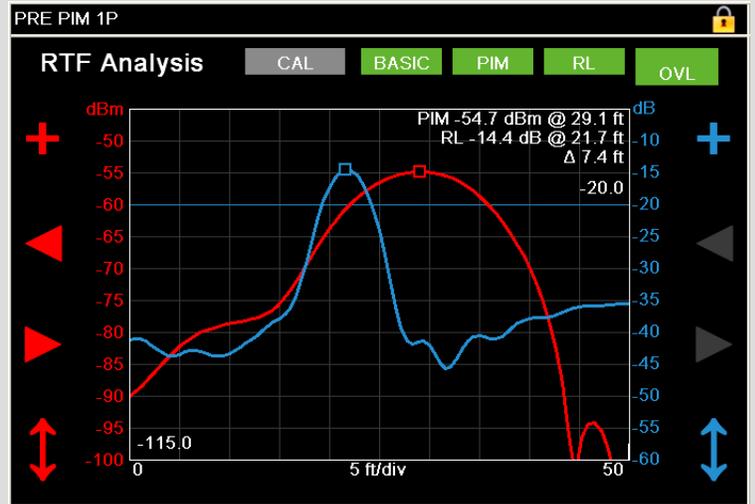
Starting RTF (vf = 0.82)

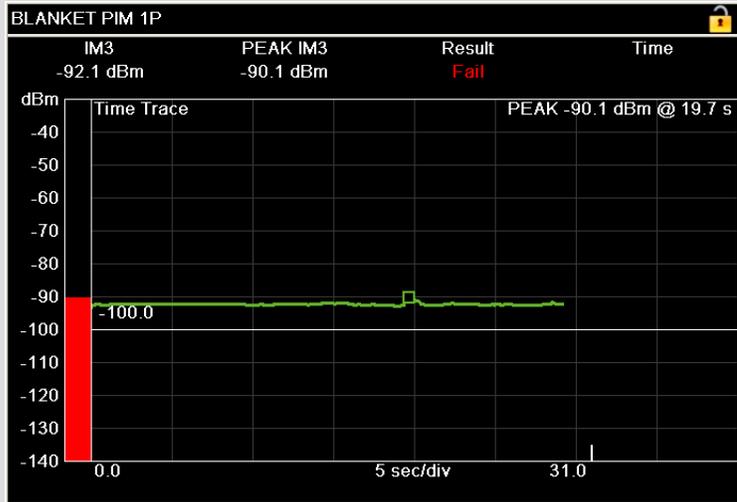
PIM Blankets Deployed: -90.1 dBm

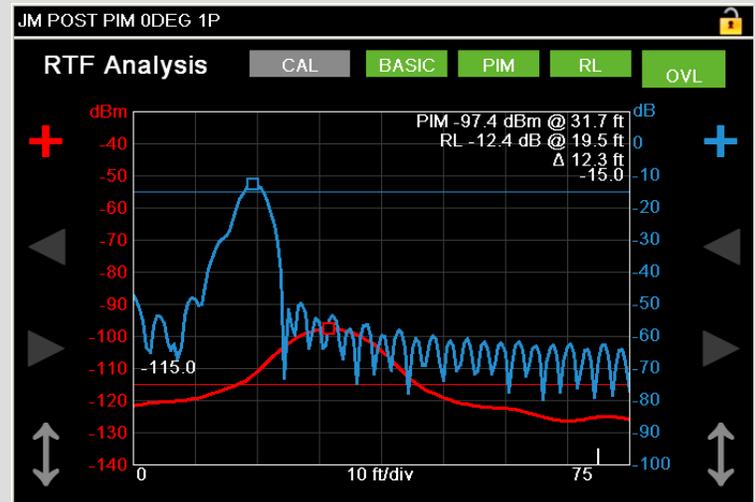
Ending RTF (vf = 0.99)

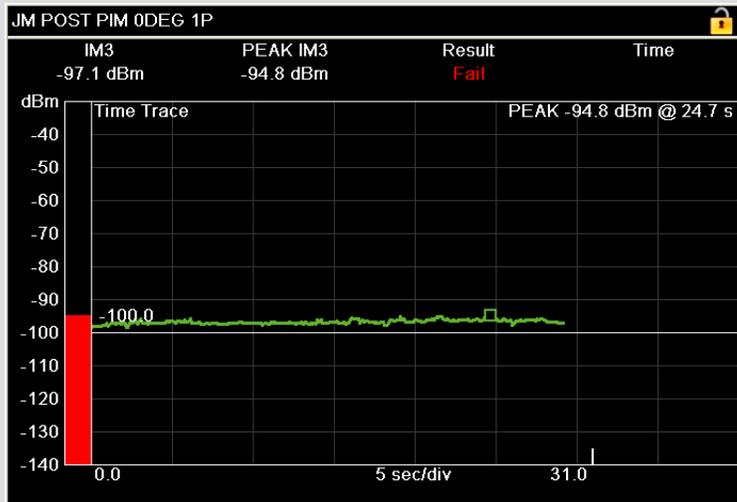
PIM Shield Bonded: -94.8 dBm

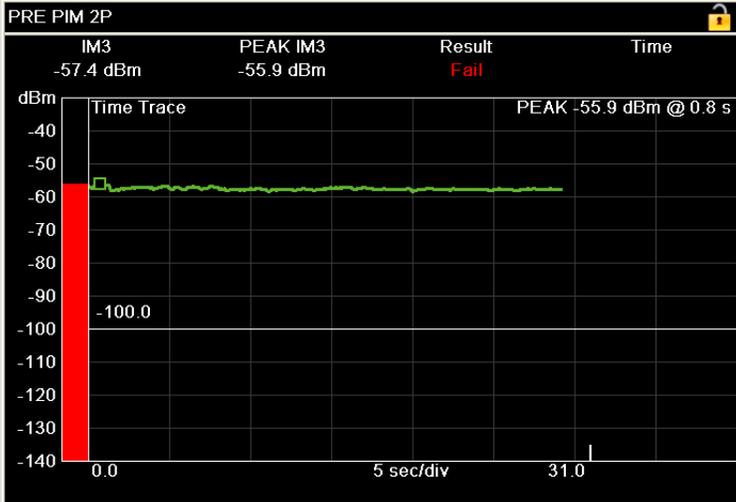
Starting PIM: -55.9 dBm

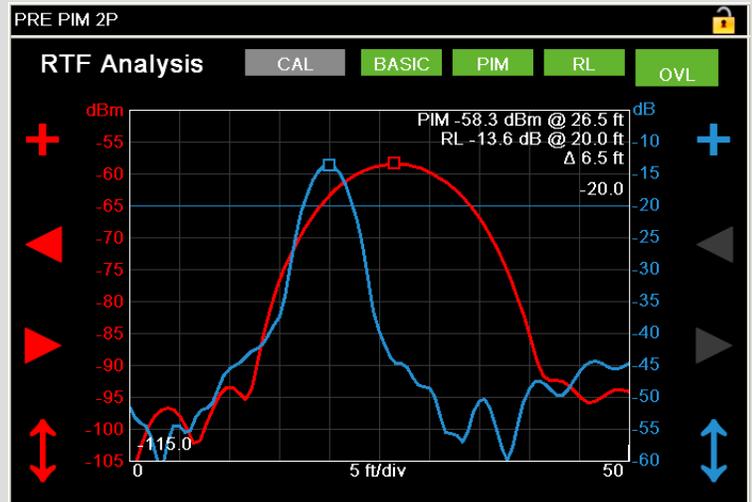
Starting RTF (vf = 0.82)

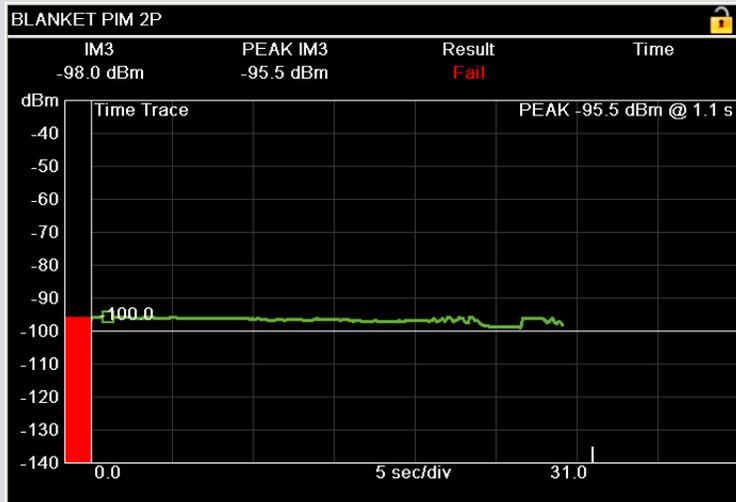
PIM Blankets Deployed: -95.5 dBm

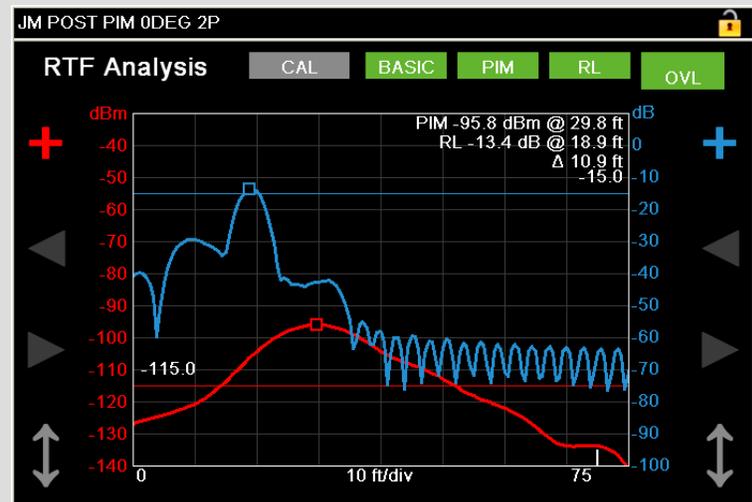
Ending RTF (vf = 0.99)

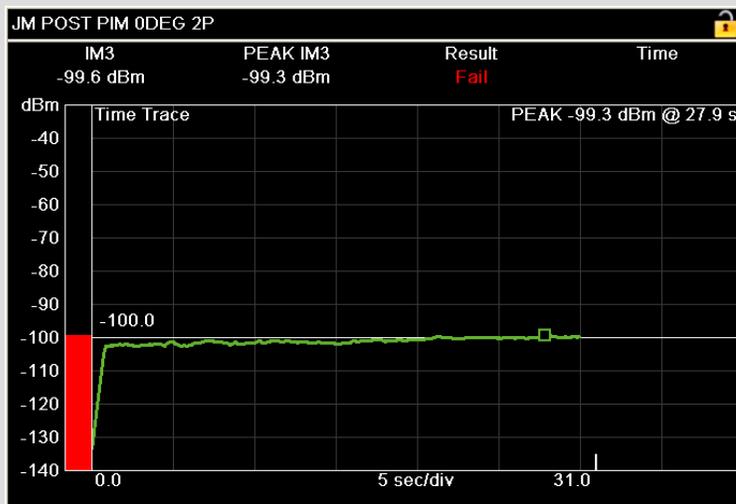
PIM Shield Bonded: -99.3 dBm

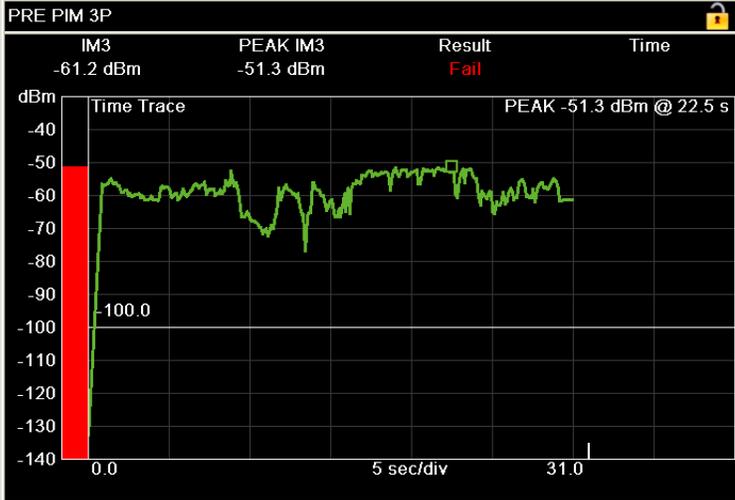
Starting PIM: -51.3 dBm

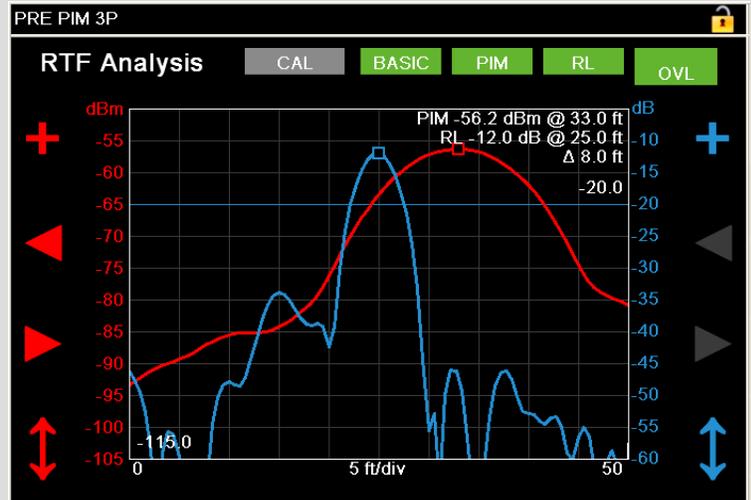
Starting RTF (vf = 0.82)

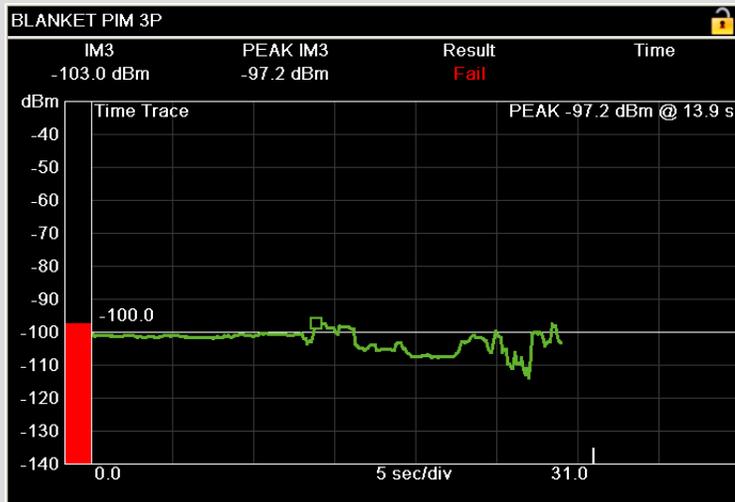
PIM Blankets Deployed: -97.2 dBm

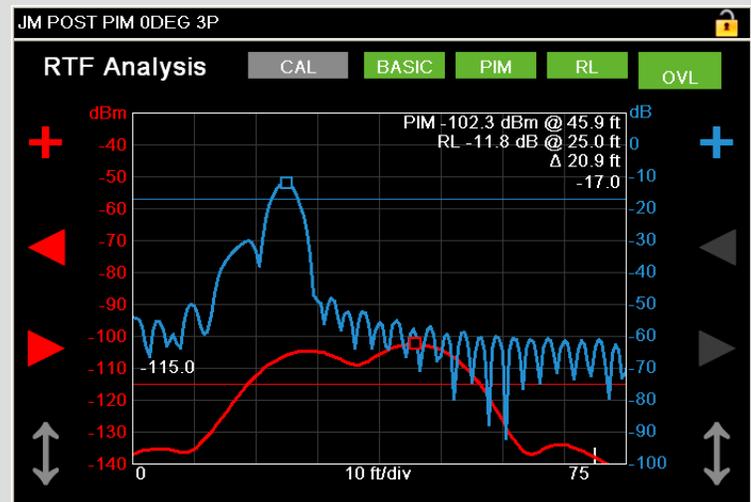
Ending RTF (vf = 0.99)

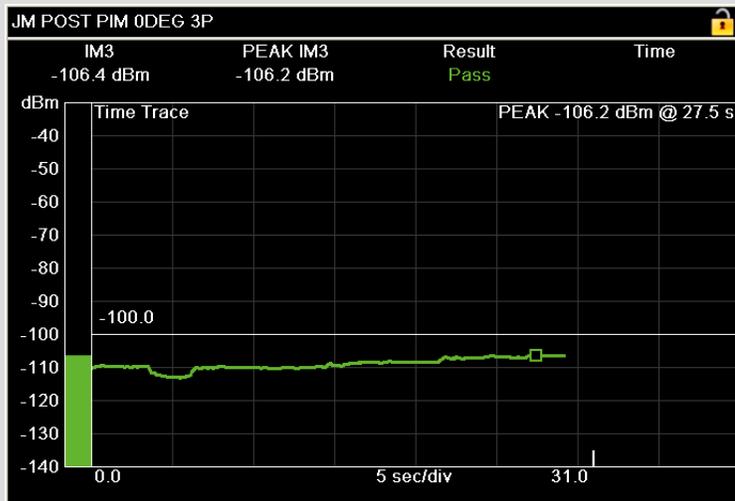
PIM Shield Bonded: -106.2 dBm

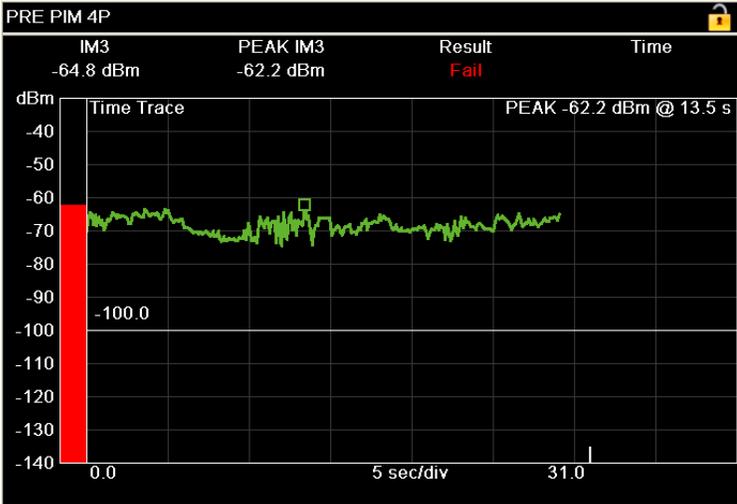
Starting PIM: -62.2 dBm

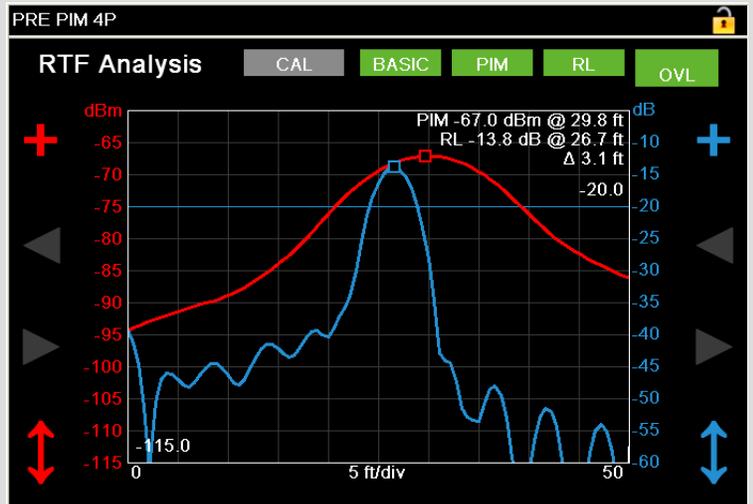
Starting RTF (vf = 0.82)

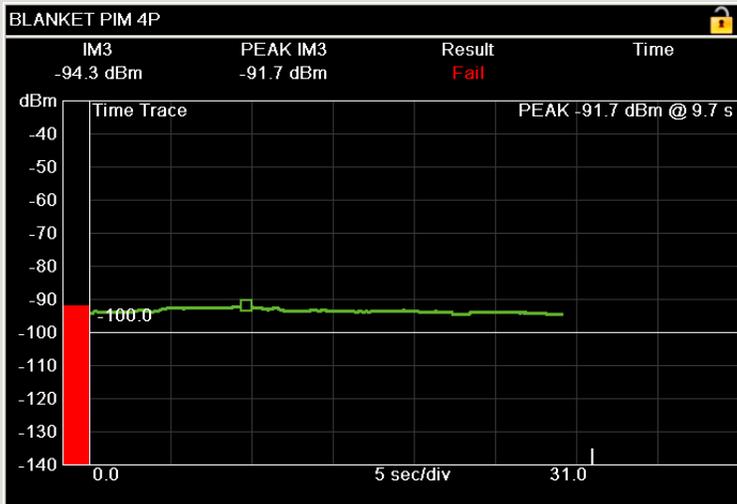
PIM Blankets Deployed: -91.7 dBm

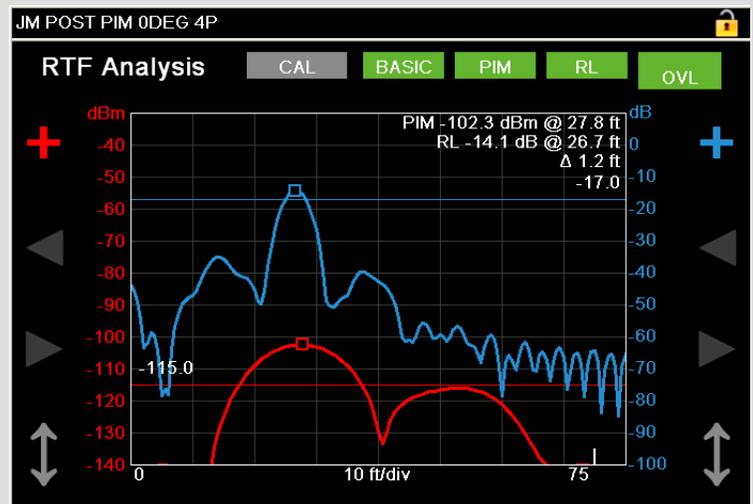
Ending RTF (vf = 0.99)

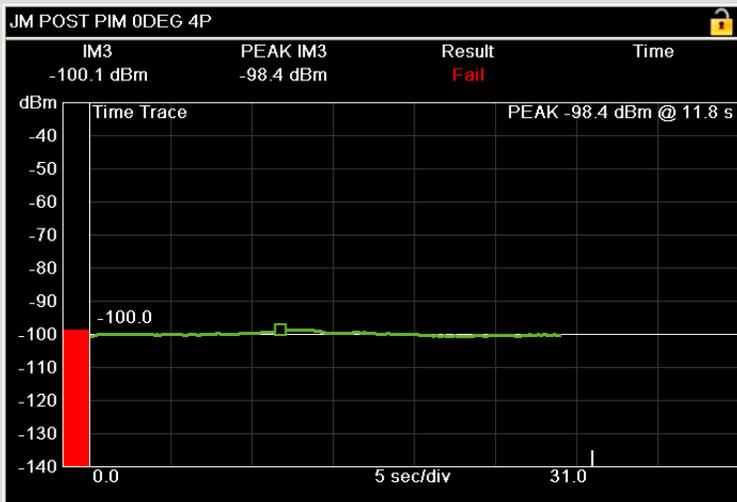
PIM Shield Bonded: -98.4 dBm
