## PIM Shield® Paint & PIM Seal™ Caulk

### CONCEALFAB LIQUID RF BARRIER SOLUTIONS:

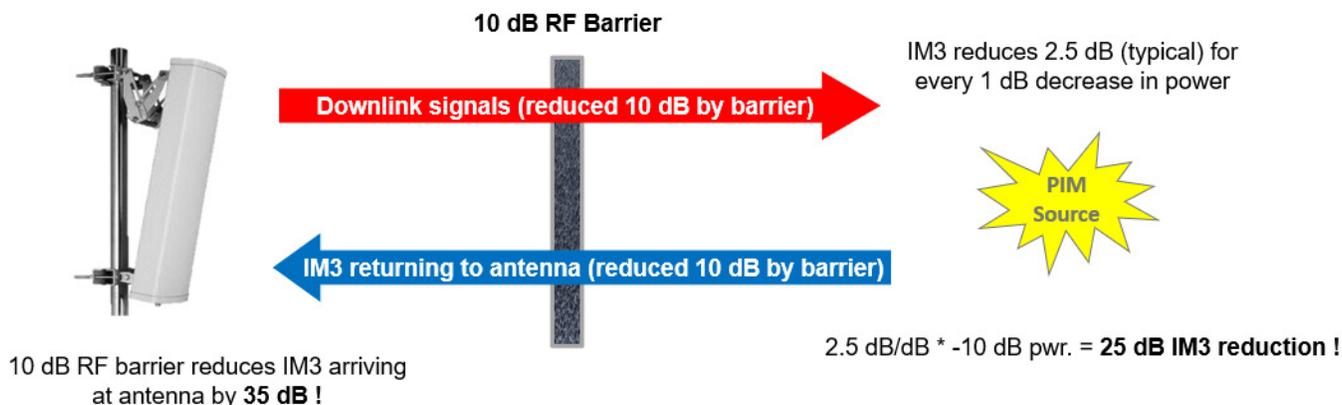
Installing a RF barrier material between an antenna and an external PIM source is a proven method for reducing PIM interference at cell sites. If the downlink signals from the antenna are absorbed or reflected away before reaching a PIM source, the PIM generated by that source is greatly reduced. A RF barrier material that reduces the signal arriving at a PIM source by 10 dB can in theory reduce the IM3 seen at the system receiver by 35 dB, as shown below.

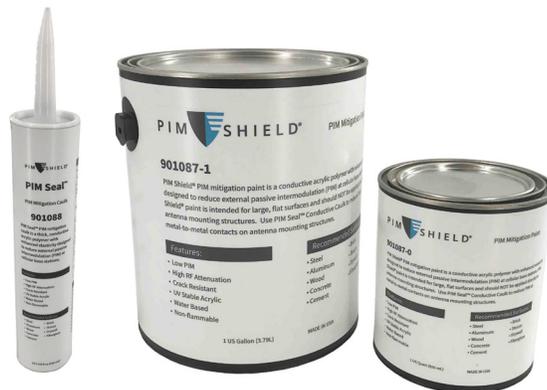
The newest additions to ConcealFab’s portfolio of permanent RF barrier products are PIM Shield® Paint & PIM Seal™ Caulk. These new liquid solutions form effective and reliable RF barriers to reduce RF energy arriving at covered PIM sources. Unlike ConcealFab’s previous barrier products that utilize a continuous layer of metal to block signals, these new liquid solutions use proprietary fillers and additives in an acrylic matrix to form a conductive barrier. Once cured, these new solutions form a flexible RF barrier with greater than 10 dB one-way signal reduction.

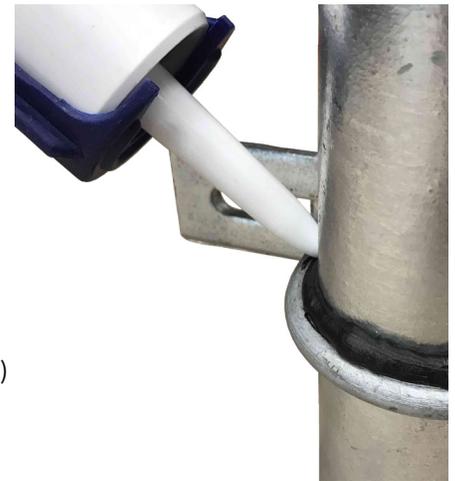
**Thermal Cycling test:**

- 5 test samples prepared
- Bead of PIM Seal™ caulk applied to both sides of a U-bolt
- Caulk allowed to cure for 7 days before testing
- Visual inspection for cracks
- Pre-thermal cycling Radiated PIM test (Near Field test, 2x20W, 700 MHz & 1900 MHz)
- Thermal cycling (15 cycles, +70°C to -40°C)
- Visual inspection for cracks
- Post-Thermal cycling Radiated PIM test (Near Field test, 2x20W, 700 MHz & 1900 MHz)
- Results – **PASS**
  - *No cracks observed*
  - *IM3 <-100 dBm for all tests*

The environmental and mechanical tests conducted confirm that ConcealFab’s PIM Shield® Paint & PIM Seal™ Caulk are highly elastic and did not form cracks when subjected to bending or thermal cycling. It is important to note that in these experiments the material was applied to bolted connections that were not loose. ConcealFab’s liquid barrier materials are highly elastic but will form cracks (and eventually generate PIM) if the surfaces where the material is applied are able to move with respect to each other.

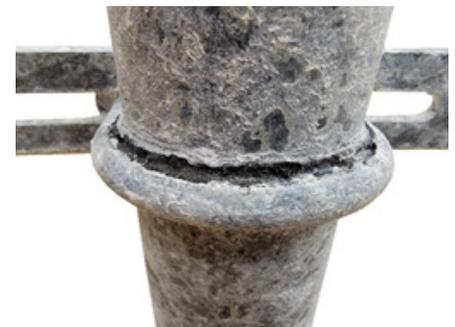
**Salt spray test:**

- Thermal cycle samples subjected to 96 hr. salt spray in accordance with ASTM B117
- Visual inspection for unexpected corrosion products
- Post-Salt spray Radiated PIM test (Near Field test, 2x20W, 700 MHz & 1900 MHz)
- Results – **PASS**
  - *No unexpected corrosion*
  - *IM3 <-100 dBm for all samples*

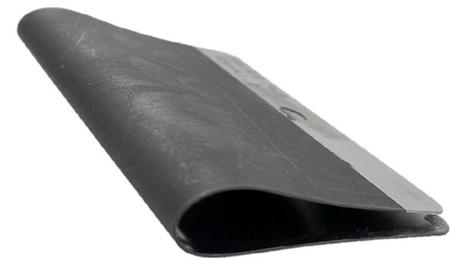
**Bend test:**

- PIM Shield® Paint applied to .025” thick steel test panels
- Paint allowed to cure 7 days before testing
- Samples bent 180 degrees over ¼” diameter mandrel
- Bend area inspected for cracks and delamination
- Results – **PASS**
  - *No cracks or delamination observed*

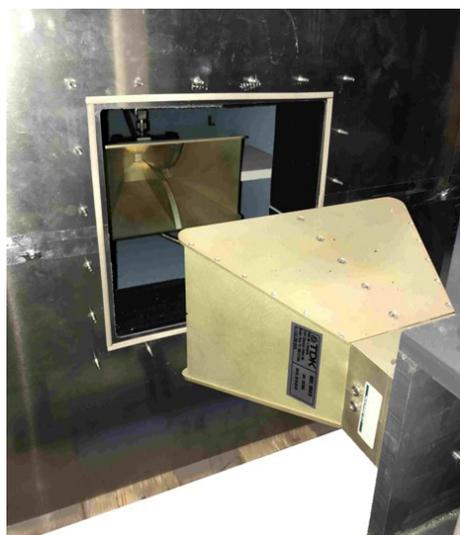
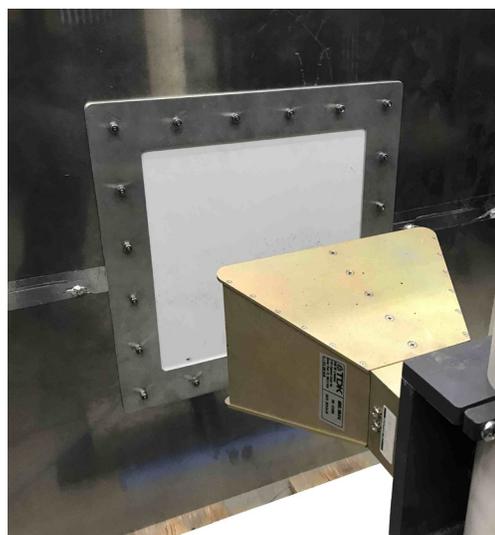
**Transmission loss test:**

- Anechoic test chamber constructed with removeable window on one side
- Broadband horn antenna placed inside the chamber
- Broadband horn antenna placed outside the chamber
- RF transparent test panels produced using ConcealFab ClearWave® material
- Test panels coated with PIM Shield® Paint or PIM Seal™ caulk
- Test samples allowed to cure 7 days before testing
- Path calibrated with no test panel installed, 1 GHz to 10 GHz
- Test panel installed and loss vs. frequency measured, 1 GHz to 10 GHz
- Typical results over frequency range:
  - 10 mil paint provided >10 dB RF loss
  - 20 mil paint provided >17 dB RF loss
  - 15 mil caulk provided >15 dB RF loss

From an RF perspective, ConcealFab’s PIM Shield® Paint & PIM Seal™ Caulk were both able to create effective barriers to block RF radiation. As predicted by theory, installing these RF barriers between an antenna and a PIM source significantly lowered the IM3 generated. PIM Reduction Test #1 confirmed that a thicker application of these materials provides greater benefit than a thinner application. When using PIM Shield® paint, ConcealFab recommends applying 2 coats at 10 mil wet thickness per coat for maximum benefit. PIM Reduction Test #2 shows that shielding effectiveness improves as the material cures. ConcealFab’s PIM Shield® Paint & PIM Seal™ Caulk are water-based, and their conductivity increase as the water evaporates during cure. While significant site improvement should be expected immediately after application, maximum benefit will not occur until the paint or caulk has fully cured (7 days).

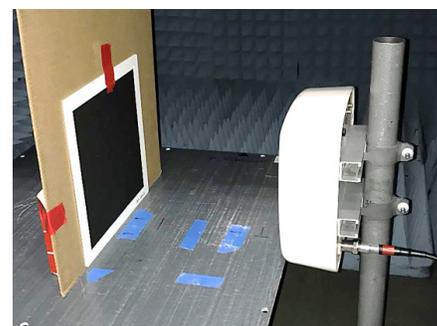
**Radiated PIM test:**

- Test panels used for transmission loss test placed 1 wavelength in front of 10 dBi panel antenna
- Radiated PIM test performed (Near Field test, static, 2x20W, 700 MHz & 1900 MHz)
- Results - **PASS**
  - IM3 performance <-100 dBm for all samples

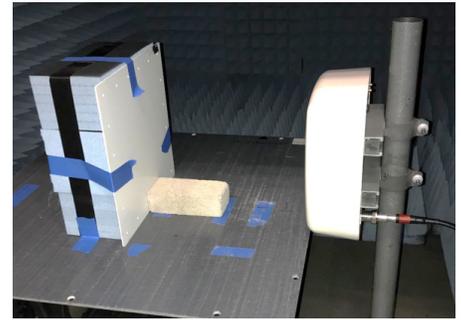
**PIM Reduction Test 1:**

- RF absorber shroud created with opening on one side
- Diode PIM source placed inside opening
- Radiated PIM test performed (Near Field test, static, 2x20W, 700 MHz & 1900 MHz) without painted panel installed
- Test panel installed between PIM source and antenna (painted side of panel held in contact with RF absorber)
- Radiated PIM test repeated
- Change in IM3 level recorded
- Results:
  - 10 mil paint reduced IM3 by >28 dB
  - 20 mil paint reduced IM3 by >47 dB
  - 15 mil caulk reduced IM3 by >30 dB

Note: This test does a fair job of demonstrating the concept but typically shows lower PIM reduction than predicted by theory. Curvature of the test panels results in an imperfect seal against the RF absorber shroud, allowing indirect RF paths to exist between the PIM source and the antenna.

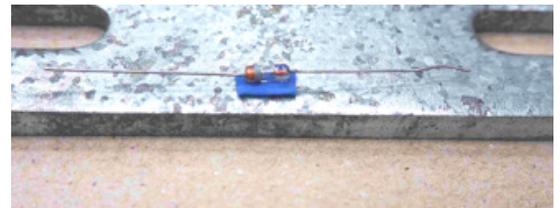
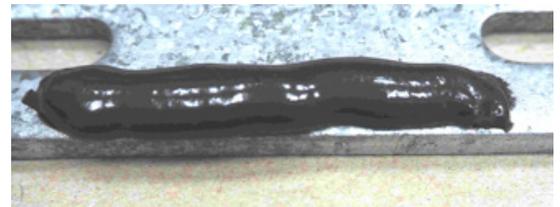
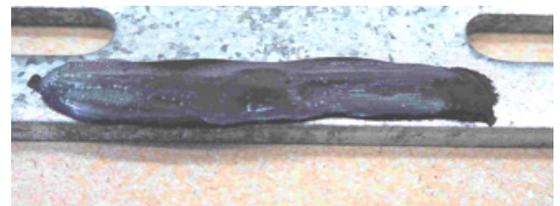
**PIM Reduction Test 2:**

- Germanium diode taped to metal bracket
- Radiated PIM test performed (Near Field test, static, 2x20W, 1900 MHz)
- Bead of PIM Seal™ caulk applied over diode
- Radiated PIM test repeated with caulk still wet
- Radiated PIM test repeated after 1-, 4- and 7-days cure
- Change in IM3 level recorded
- Results:

Condition	IM3(dBm)	IM3 Reduction (dB)
Diode only	-79.9	n/a
Caulk applied (wet)	-96.5	16.6
1 day cure	-100.8	20.9
4 days cure	-113.3	33.4
7 days cure	-116.1	36.2

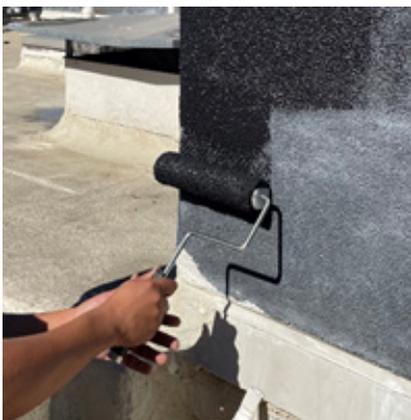
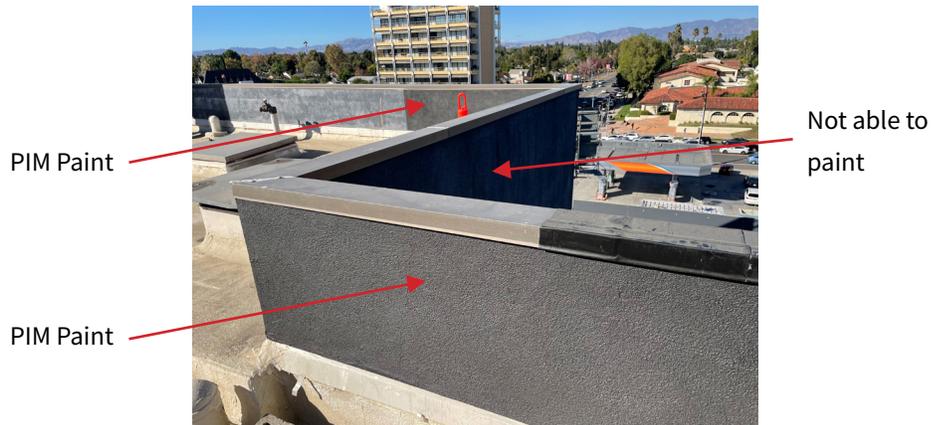
A US operator invited ConcealFab to install PIM paint on one of their rooftop sectors to evaluate the material’s ability to mitigate PIM. A PIM hunting crew had previously visited the site and reported that the stucco parapet wall directly in front of the antennas was generating PIM. The contractor proved this by placing a PIM blanket over the wall and showing that the average noise level reduced with the PIM blanket in place. The operator contacted the building owner and received approval to paint the parapet wall with PIM Shield® Paint prior to ConcealFab arriving on site.

Once on site, ConcealFab verified the contractor’s results by temporarily installing PIM Foil over the areas where PIM Paint was planned to be applied. Additional PIM hunting showed that the largest remaining PIM source was a section of exterior stucco wall in front of the antennas. Unfortunately, we did not have permission (or the equipment) to apply paint to the exterior of the building, so two coats of PIM Paint were applied by roller to the areas we did have permission to cover.

Measured data showed that applying the PIM Paint to the parapet wall improved the average noise level by >4 dB in the two frequency bands impacted. To achieve additional benefit, the operator will need to either re-position the antennas to avoid illumination of the exterior wall area or work with the building owner to gain permission to apply PIM Shield® Paint to the exterior surface.

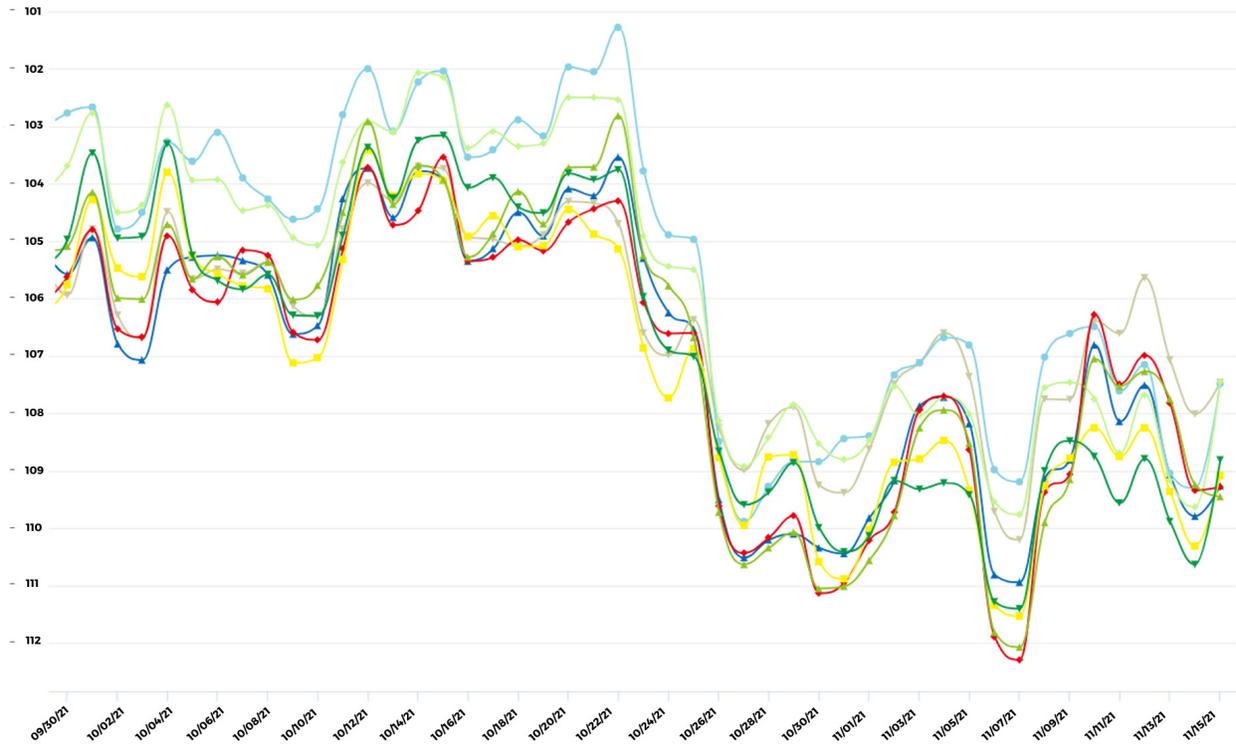
Average uplink noise vs. time on sector where PIM Paint was installed
