Radiated PIM Test Report

<u>Part number(s):</u> 900939-10

<u>Description:</u> The PIM Shield 1-Position Snap-in Adapter provides a low passive intermodulation (PIM) method to secure RF, fiber, power and RET cables using snap-in cable hangers in high risk PIM zones. The 1-position snap-in adapter is secured using two PIM Shield Cable Support Straps.

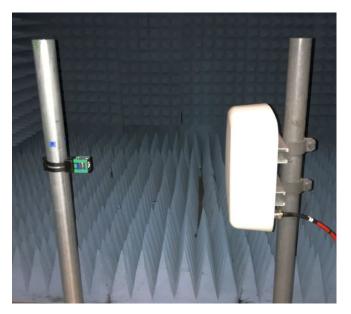
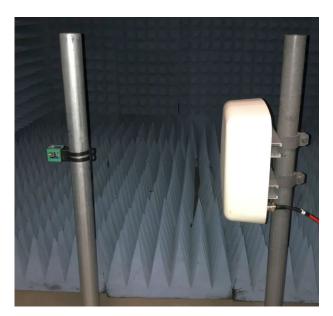
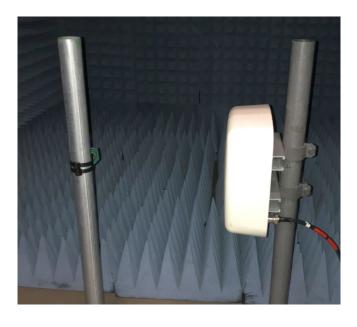
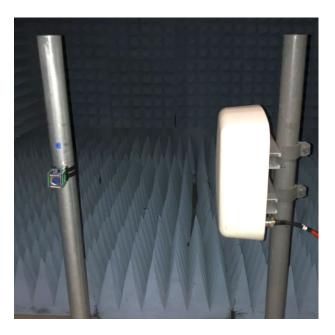
Test set-up photos 700 MHz:

BACK

LEFT SIDE

<u>Test conditions</u>:

Tested in accordance with proposed IEC 62037-8 specification under the following test conditions:

Object type: Non-flatTest type: Near Field

• Dynamic stimulus: Tap DUT with fiberglass rod while PIM testing

• Test power: 2x 43 dBm test tones

• IM product measured IM3

• Pass/Fail level: -97 dBm (-140 dBc)

• Frequency bands: 700 MHz band (F1 = 728 MHz, F2 = 757 MHz, IM3 = 786 MHz)

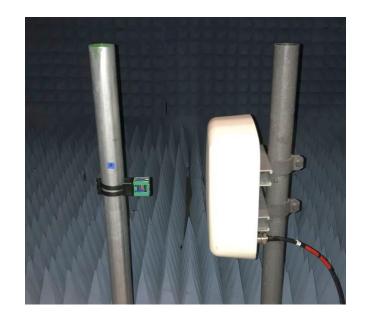
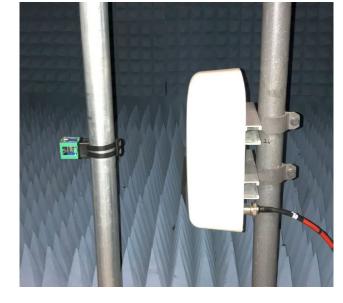
Test set-up photos 1900 MHz:

FRONT BACK

1900 MHz band (F1 = 1930 MHz, F2 = 1990 MHz, IM3 = 1870 MHz)

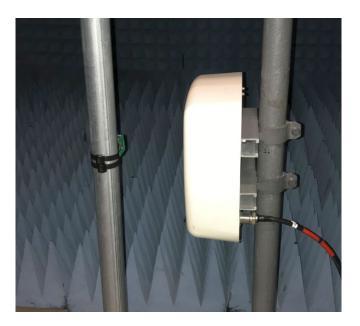
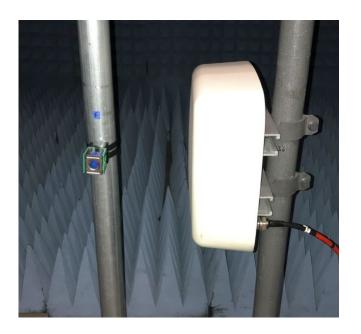
RIGHT SIDE LEFT SIDE
