Part number(s): 900638-10, 900712-10, 900714-10, 900715-10, 900443-XX-XX, PSCB

Description: Low PIM cable support mount designed to secure Cable Support Blocks to round structural members at a cell site using PIM Shield Cable Straps. The Cable Support Blocks are attached to a galvanized-steel threaded rod kit, which is secured to a plastic Threaded Rod Adapter. The Threaded Rod Adapter is installed in a Universal Round Member Saddle Bracket and secured to the round member using two plastic straps to prevent metal-to-metal contact between the threaded rod and the site structural member. Assembly torque = 10 FT-LB on all fasteners.

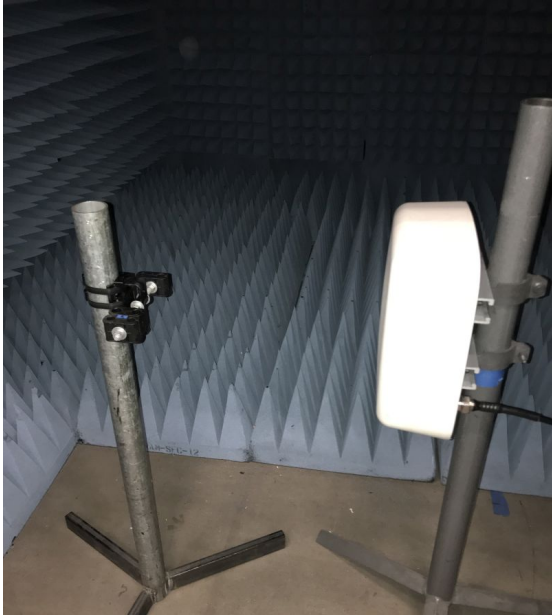
FRONT

Test set-up photos 700 MHz:

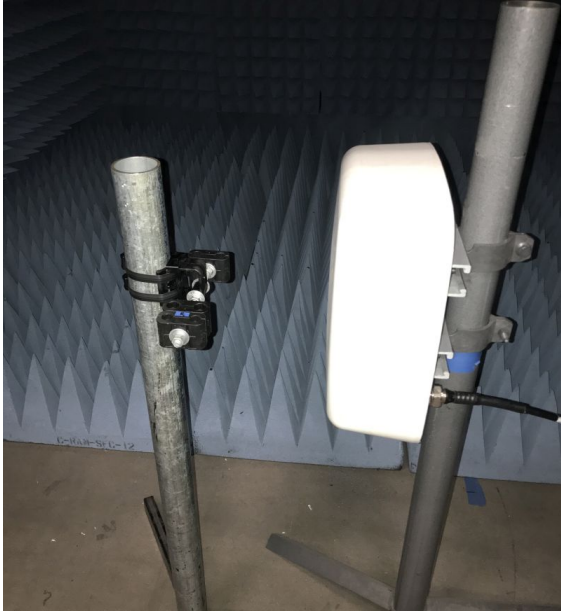
FRONT

Test set-up photos 1900 MHz:
